2. DEPLOYMENT AND TESTING OF THE DIAMOND CORING SYSTEM ON LEG 124E¹

Steven P. Howard²

OVERVIEW AND INTRODUCTION

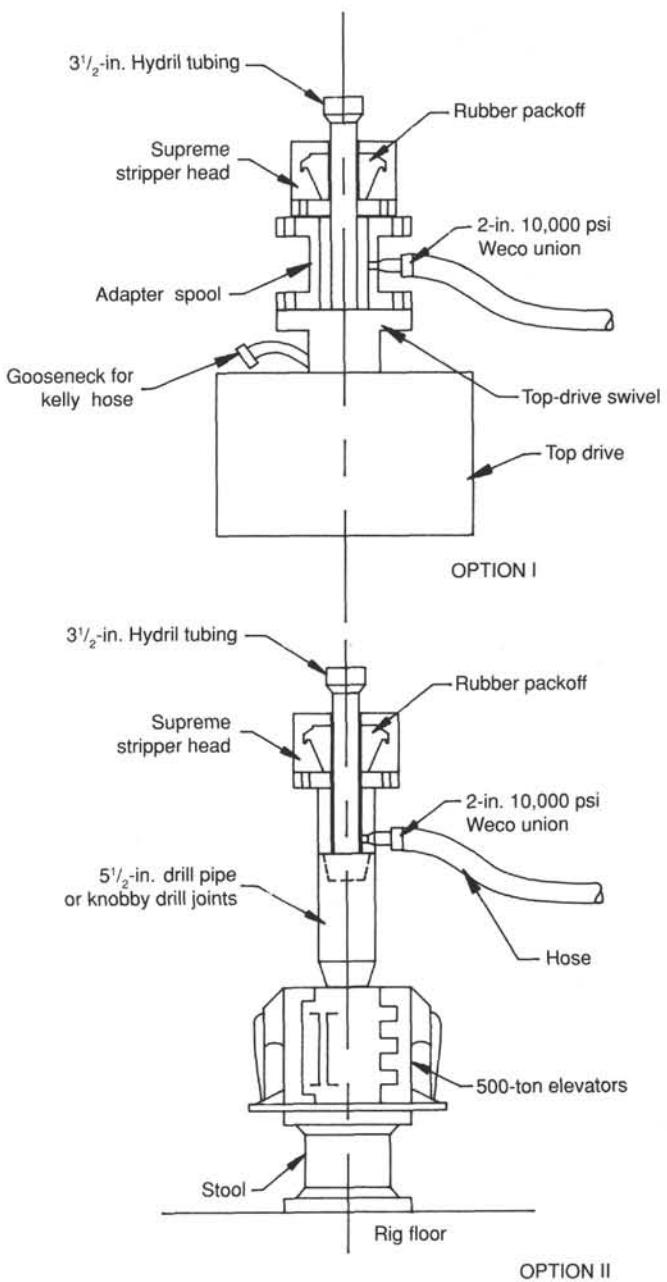
Figure 10. Diagram of tubing stripper-packoff/diverter system.

The Supreme stripper head was rigged up on top of the Varco top-drive swivel (Fig. 10). It should be noted that in the future the stripper head can be rigged up on top of the Bowen/WKM valve stack. The valve stack was removed because it was thought there was not enough internal clearance (4-in. ID) to pass the DCS coring assembly (4-in. OD bit and reamer shell). That, however, was not the case, because the DCS coring assembly was tripped in the hole prior to picking up the top-drive assembly. Only the 3.868-in. (OD) connections on the 10-ft Hydril drilling joints are required to pass through the top-drive/swivel assembly. During actual coring operations with the DCS it was found that the stripper head would seal with flow rates through the top drive of 250 gallons per minute (gpm) and standpipe pressures of 1000 psi. As the stripper rubber wore down, sealing around the tubing could be enhanced by positioning a 3.868-in. (OD) Hydril box connection in the stripper-head seal area. In the future the sealing capacity around the tubing needs to be increased threefold to allow use of effective flow rates (pressures) for cleaning and conditioning the pilot hole. The DCS core-barrel system (Longyear HQ) was rigged up. All connections on the DCS outer core-barrel system were Baker-Loked together. The Bowen-Itco-type releasing spear grapples were checked in the inside diameter of the 3 1/2-inch Hydril tubing.

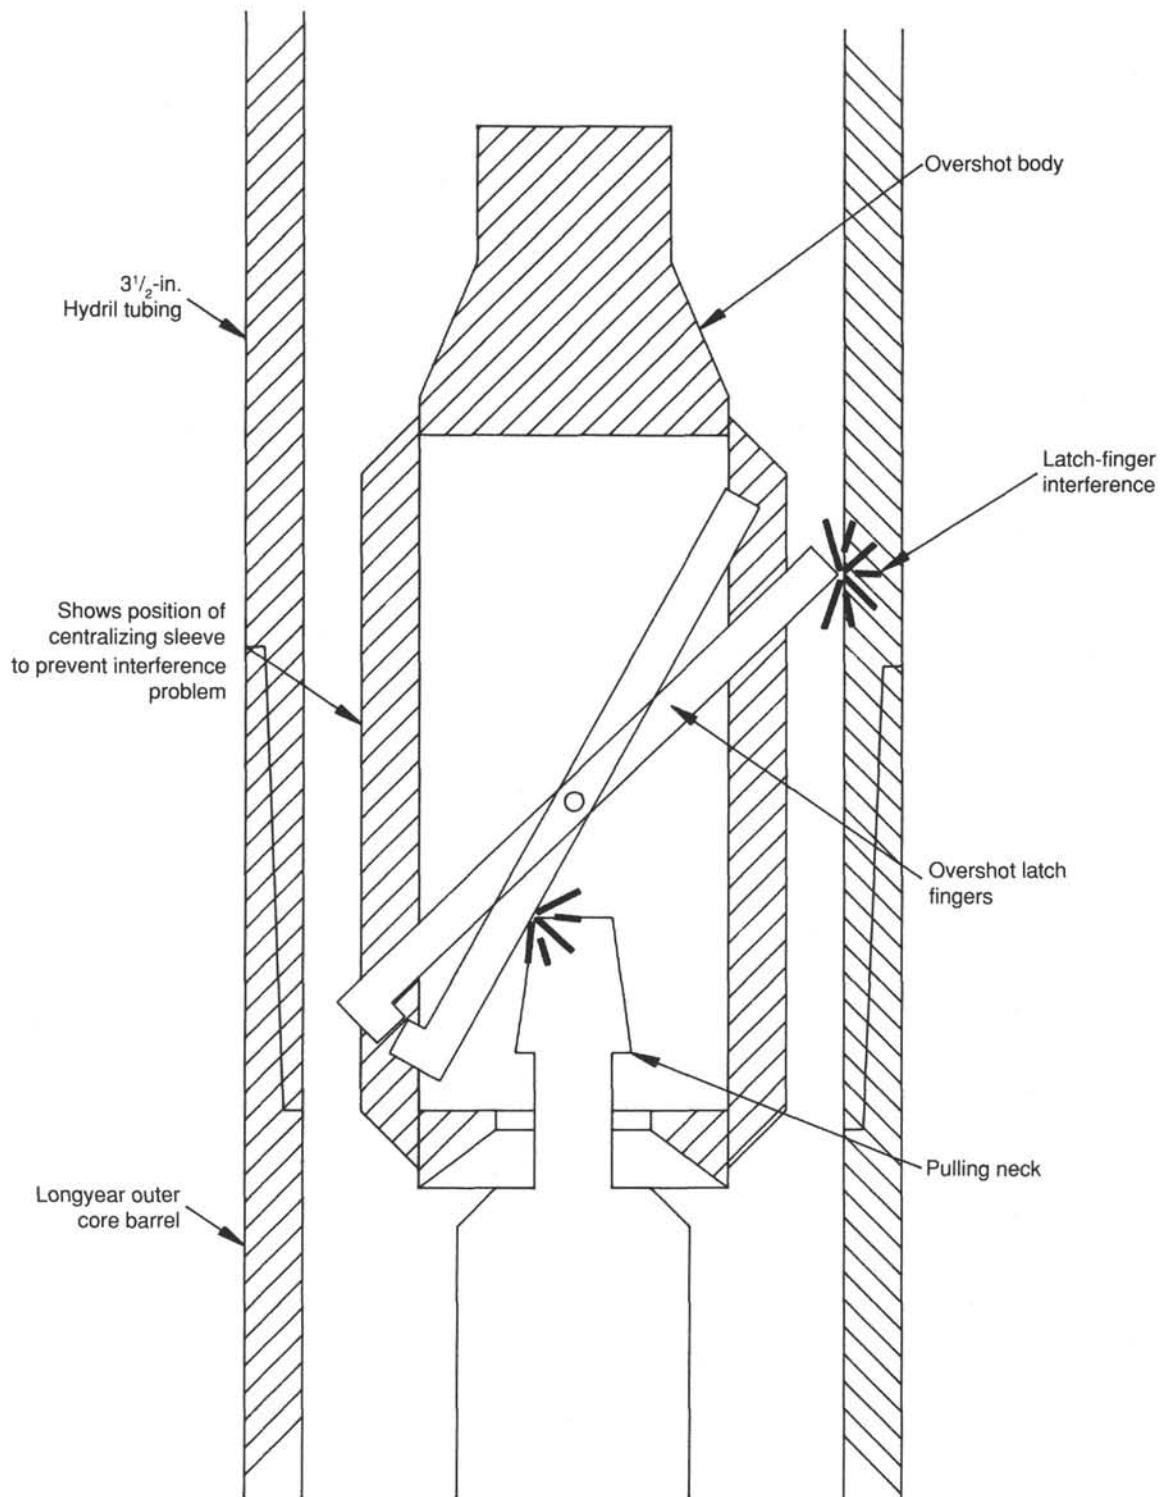
Figure 13. Diagram showing Longyear overshot latch-finger interference.

Examination of the DCS outer core barrel revealed that the inner core barrel was not jammed or silted up. The Longyear latch fingers instead were found to be jammed to one side of the DCS outer core barrel (see Fig. 13). Further investigation revealed that a square sleeve that provided centralization for the latch fingers had been left off the assembly. The sleeve had been omitted because to run the sleeve in the 2.942-in. (ID) tubing, the outside diameter of the sleeve would have had to be reduced. The concern was that the turned-down sleeve would have been too thin to run safely. Without some type of sleeve, the latch fingers would have the freedom to hang up on one side of the core barrel. When the Longyear overshot was initially run, the question was raised about the lack of centralization. The explanation was that the overshot is routinely run either way, with or without a sleeve. A sleeve was promptly made for the overshot to correct the problem for the next bit run. The spang-jar shaft was also repaired, and the nut welded in place.
