1. OPERATIONS REPORT¹

Michael A. Storms²

EXECUTIVE SUMMARY

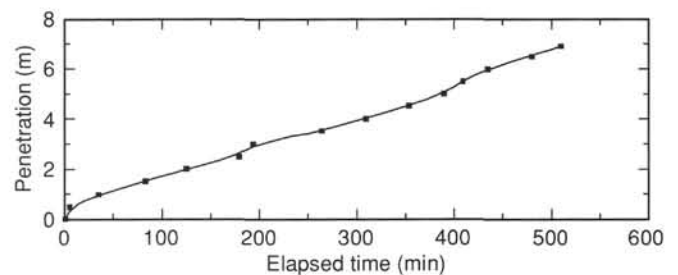
The drilling of the 7-1/4-in. hole with the 2-cone center bit was perhaps one of the highlights of the leg. The bit drilled exceptionally well and was still drilling ahead at an average penetration rate of 0.8 m/hr (Fig. 7) with a maximum and minimum rate of 0.5–2.0 m/hr. The drilling test was terminated after 6.8 m of hole was drilled in (3.75 rotating hr) so that both bit and center bit could be recovered before total failure, thereby yielding important design information. Prior to pulling out, the hole was displaced with 12-lb/gal mud and a wiper trip was made to check stability. Fill was tagged at 3.5 mbsf, indicating that even though the hole was drilled with a 7-1/4-in. diamond bit, it was no more stable than those drilled with the tricone bits. The center bit was then recovered via the forward coring line without incident and the drilling assembly was tripped back to the drillship. The coring line was coated with preservative on this last trip out of the hole. When recovered, both bits were in excellent condition and obviously could have drilled farther. The carbonado diamond proved itself worthy on this final test on the East Pacific Rise, and the 2-cone 4.0-in. center bits continued their impressive list of successes dating back to Leg 132. Both the bearings and cutting structure on the center bit were good but there was evidence of shirt-tail erosion, likely due to the abrasive formation.

Figure 7. Penetration depth below seafloor vs. elapsed time for 7-1/4-in. carbonado diamond bit run with a 4-in. 2-cone center bit.
