OCEAN DRILLING PROGRAM
LEG 137 PRELIMINARY REPORT
HOLE 504B CLEANOUT

May 1991

Preliminary Report No. 137

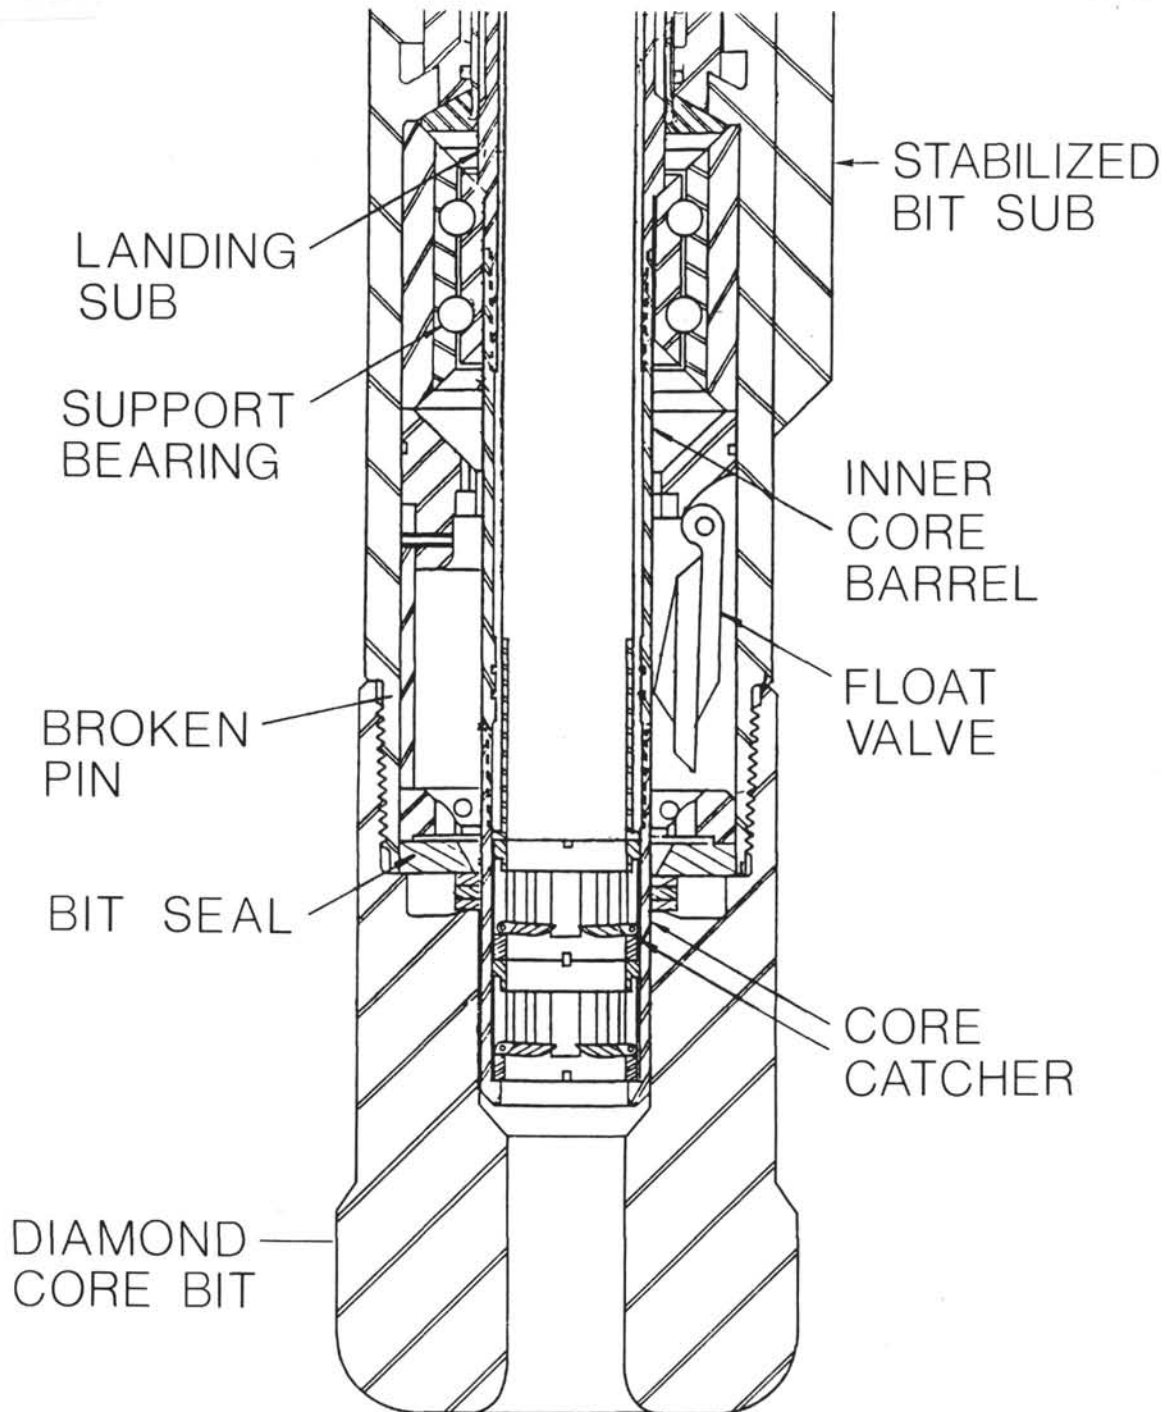
assembly had broken off at the end of Leg 111, which was left with insufficient time to recover all of the lost hardware, necessitating abandonment of the large diamond bit and assorted hardware at the bottom of the hole. There were also suggestions of possible problems with the casing, and it was feared that wall rocks might have caved in on top of the junk since Leg 111.

Figure 2. Schematic of the diamond coring assembly lost in Hole 504B at the end of Leg 111. The pin thread of the stabilized bit sub-assembly broke, leaving the core barrel, support bearing, float valve, and diamond core bit in the hole. The core barrel and outer race of the support bearing were recovered before Leg 111 ended. The remainder -- the inner race and ball bearings from the support bearing, the float valve, and the diamond core bit -- were successfully fished and milled from the hole during Leg 137.

Despite these uncertainties, Leg 137 was able to run straight to the junk from virtually the beginning of remedial operations. Cleaning the junk from the bottom of the hole required less than one week of straightforward operations (Fig. 4), including one fishing attempt with a junk basket and five mill runs with boot baskets to capture pieces of broken-up metal. These returned with parts or whole pieces of all the lost hardware, including recognizable pieces of the diamond bit. This was followed by a run with a tri-cone drill bit to verify that the hole was clean, which deepened the hole without coring by 8 m to a total depth of 1570 mbsf.

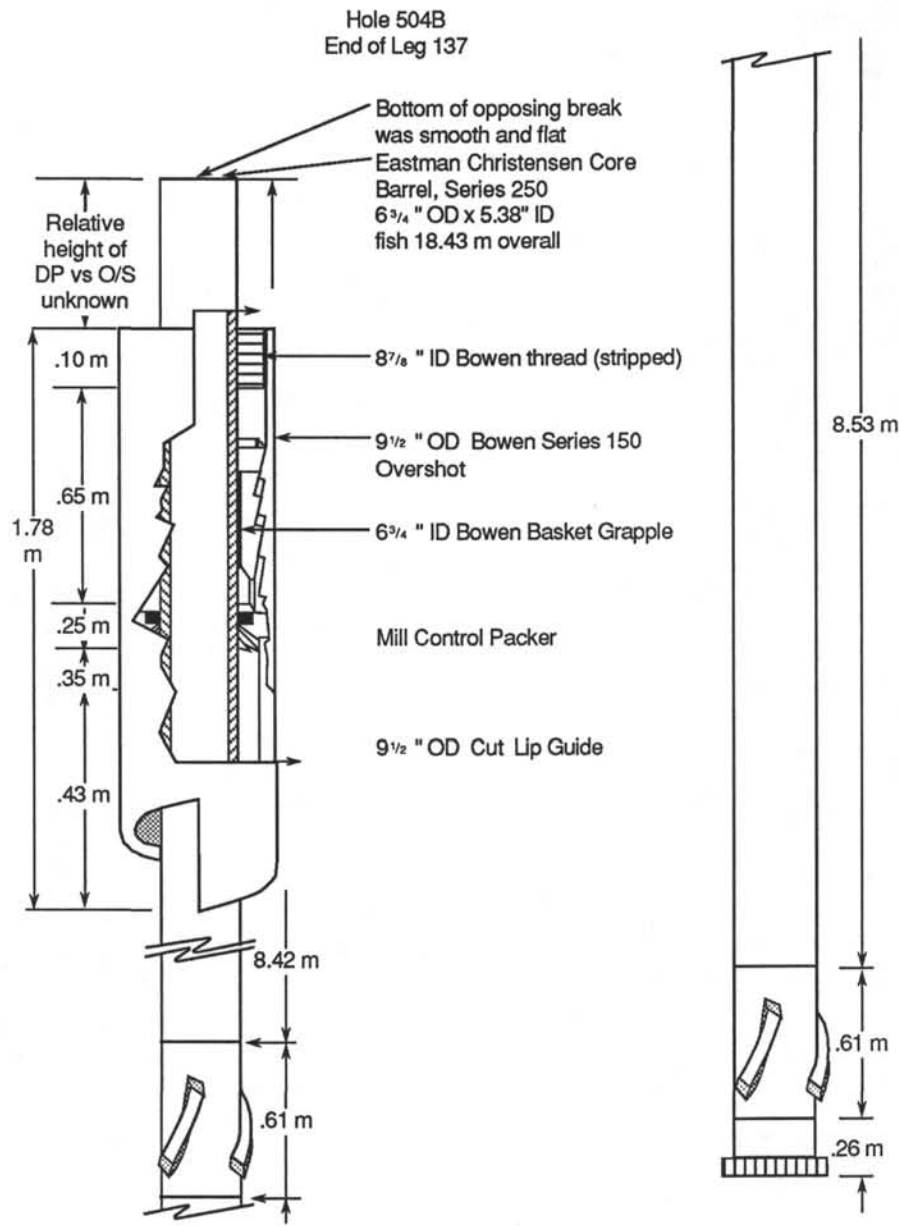
The diamond core barrel also yielded mixed results, with extremely slow penetration but very good recovery. Two runs resulted in a recorded advance of only 3.1 m (which could be in error because of the effects of tides) and a calculated recovery of 79%. The first diamond bit was extremely worn after less than 2 m of penetration, indicating that the bit matrix material was too soft for the hard, abrasive formation. The second diamond bit behaved in a similar manner downhole but was not recovered because all 18 m of outer core barrel broke off in the hole, with the bit at the bottom.

Such a long, narrow piece is normally the easiest kind of junk to fish from a hole with the appropriate tools, and in fact the first fishing overshot apparently did engage and lift it some distance up the hole. However, the fishing overshot itself broke off, leaving a compound fish as detailed in Figure 5. This remains eminently fishable with the appropriate fishing tools. Unfortunately, the proper tools were not on board, although a second fishing attempt was made with a modified taper tap. When this failed, the decision was made not to risk damage to the fish by attempting to retrieve it with a "rig-engineered" solution, but

Figure 5a. Schematic diagram of the Christensen core barrel and Bowen overshot grapple, which comprise the "fish" left in the hole at the end of Leg 137. The grapple has probably slid down the outer surface of the core barrel some distance. It is impossible to tell for certain the position of the overshot grapple relative to the top of the core barrel, but ribs on the outside of the core barrel restrict the grapple's position to the top 8 m of the core barrel.

instead to leave the fish in its easily retrievable condition, in a position to be removed with proper equipment during a future leg.

This important success was tarnished by a frustrating inability to retrieve a much less serious piece of junk lost at the end of coring tests. This disappointment can be attributed to a defective fishing tool and a lack of time to procure and deploy any further appropriate tools, not to any difficult presentation of the junk itself. In fact, such tool losses and fishing jobs are not at all unusual in drilling any deep hole, and in this case it is virtually certain that the lost outer core barrel can readily be fished with the proper tool. Furthermore, Hole 504B has a history of being open to total depth on multiple revisits, so the fish can be

expected to remain clean and in easily retrievable condition for a reasonable period of time. With appropriate fishing tools, it should pose little risk to a revisit in the near future.

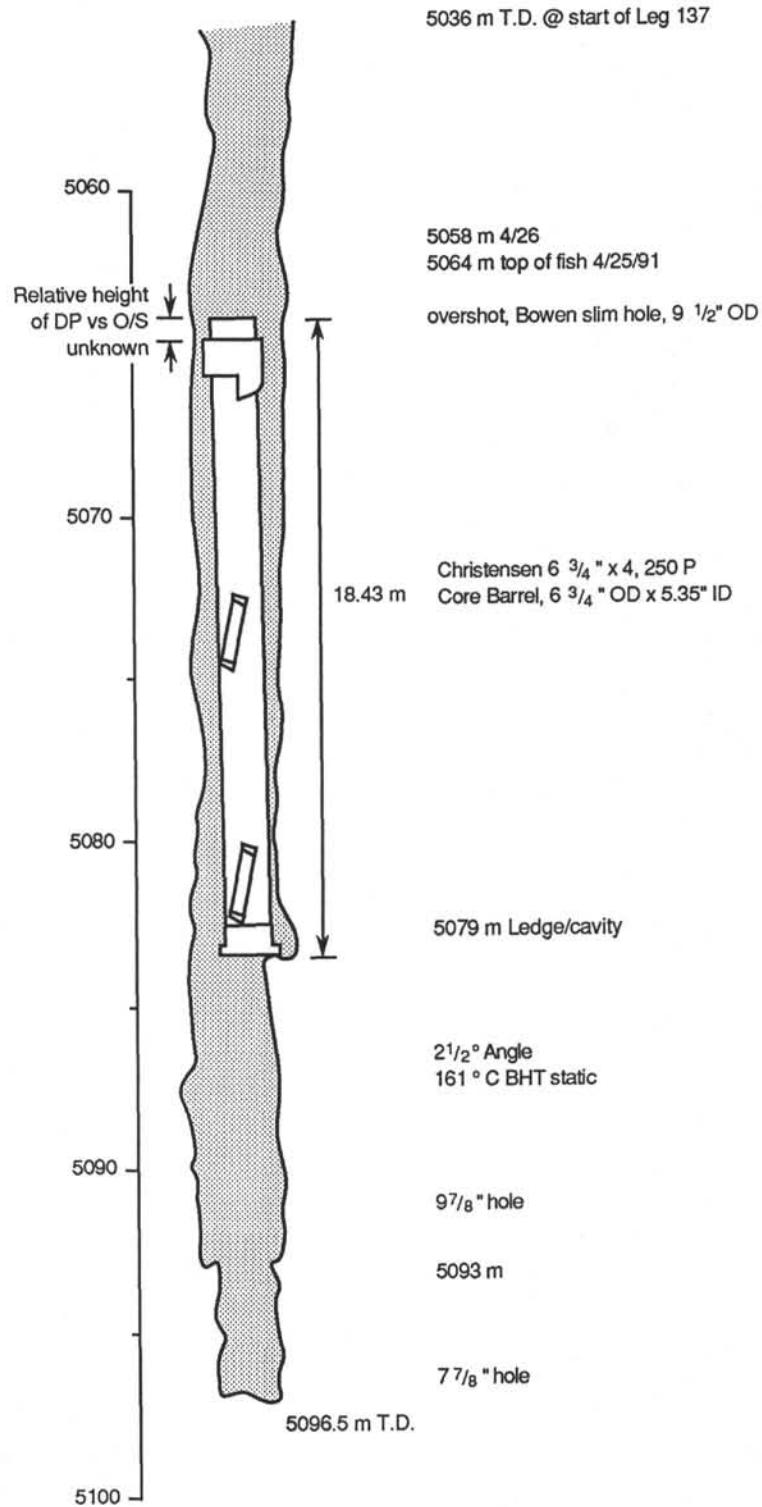
Hole 504B
End of Leg 137

Figure 5b. The inferred position of the fish in Hole 504B. DP = drill pipe (Christensen core barrel); O/S = overshot.
