15. SITE 774¹

Shipboard Engineering and Scientific Parties²

HOLE 774A

HOLE 774B

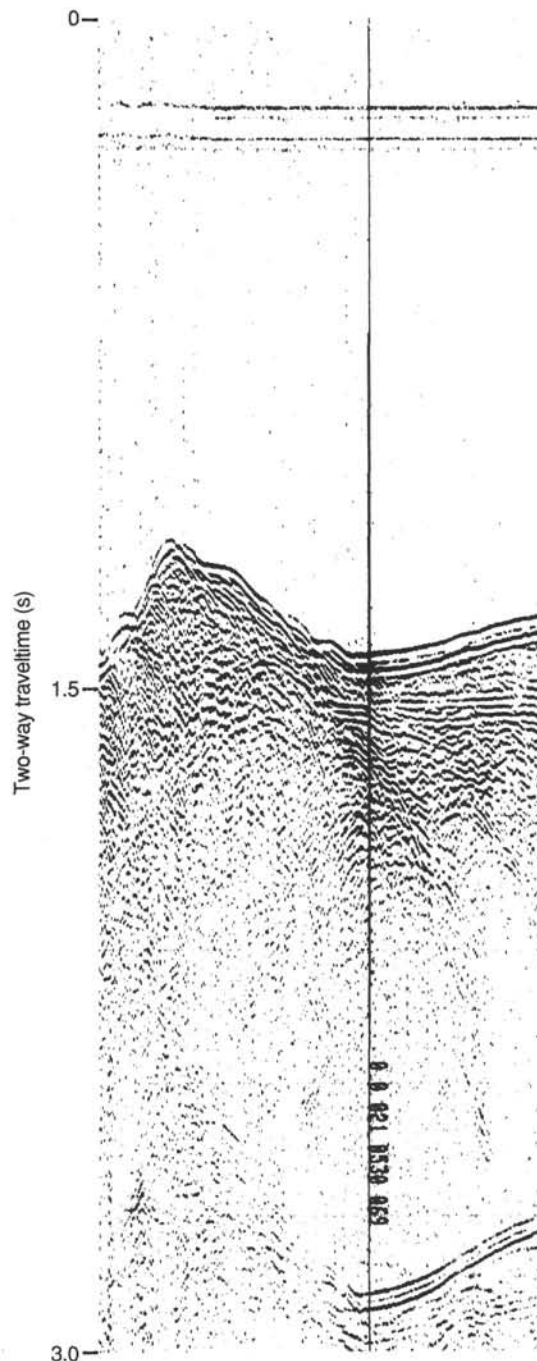
The water-gun record taken along the western margin of this basin is shown in Figure 2. The surface of the basin slopes gently and is underlain by a nearly horizontal reflector at about 0.2 s sub-bottom (estimated 150 mbsf). This reflector appears to lap against basement, where basement was expected between 150 and 200 mbsf. Figure 3 shows the *Resolution's* survey track in the vicinity of Site 774.

Figure 2. Water-gun record a short distance south of Site 774.
