OCEAN DRILLING PROGRAM
LEG 179 PRELIMINARY REPORT
HAMMER DRILLING and NERO

August 1998

Preliminary Report No. 79

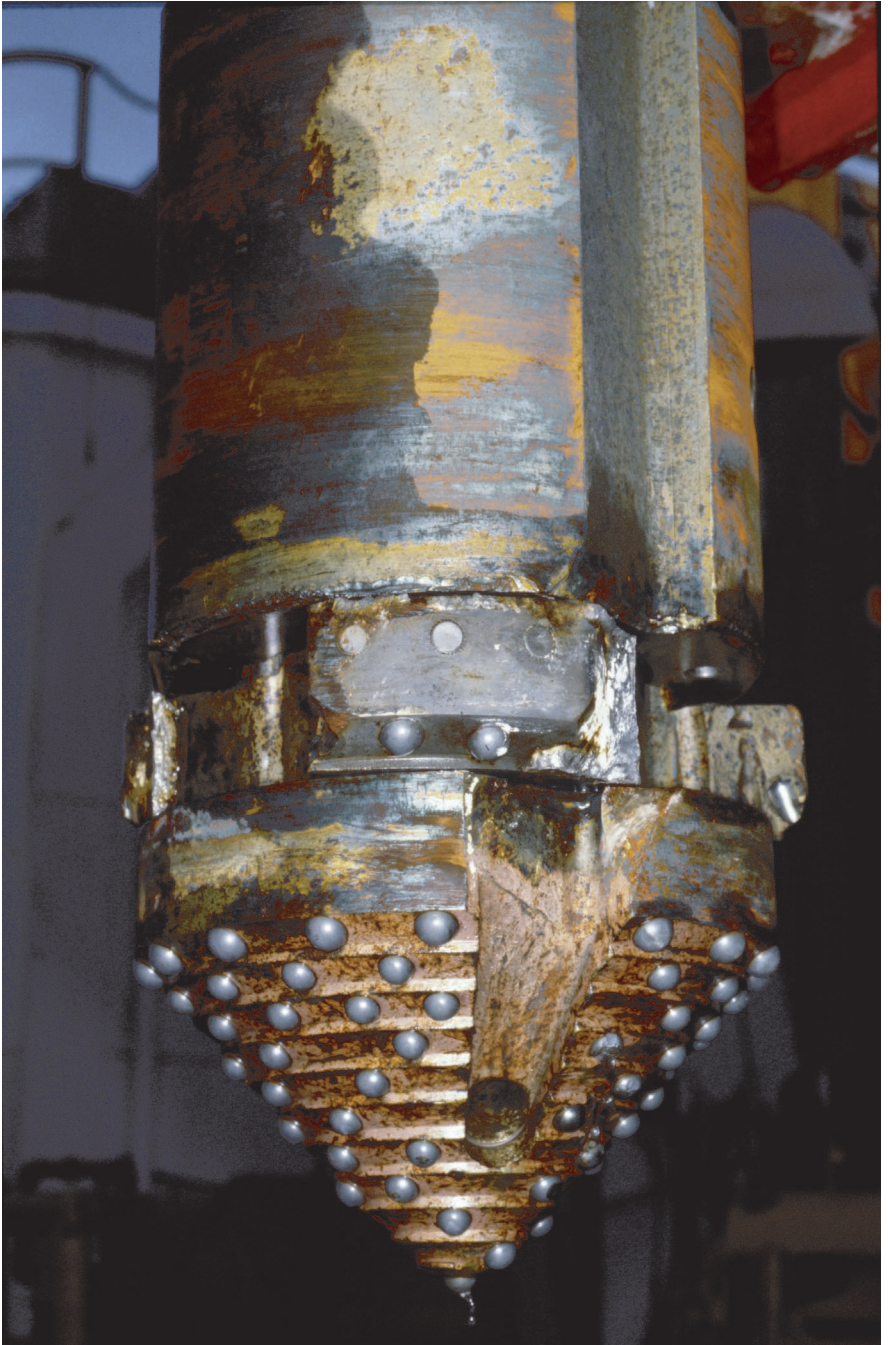
Figure 22

Once on deck the bit was inspected revealing the leading two TCIs on each of the underreamer arms were sheared or broken off (Fig. 22). The gauge surfaces of the SDS bit #2 underreamer arms were not as heavily abraded as those on the SDS bit #1. Except for the pilot bit nose TCI having been sheared or broken off, the rest of the pilot bit appeared to be in good shape. The pilot bit nose TCI was probably damaged as the bit was heaved off the seafloor during spudding.

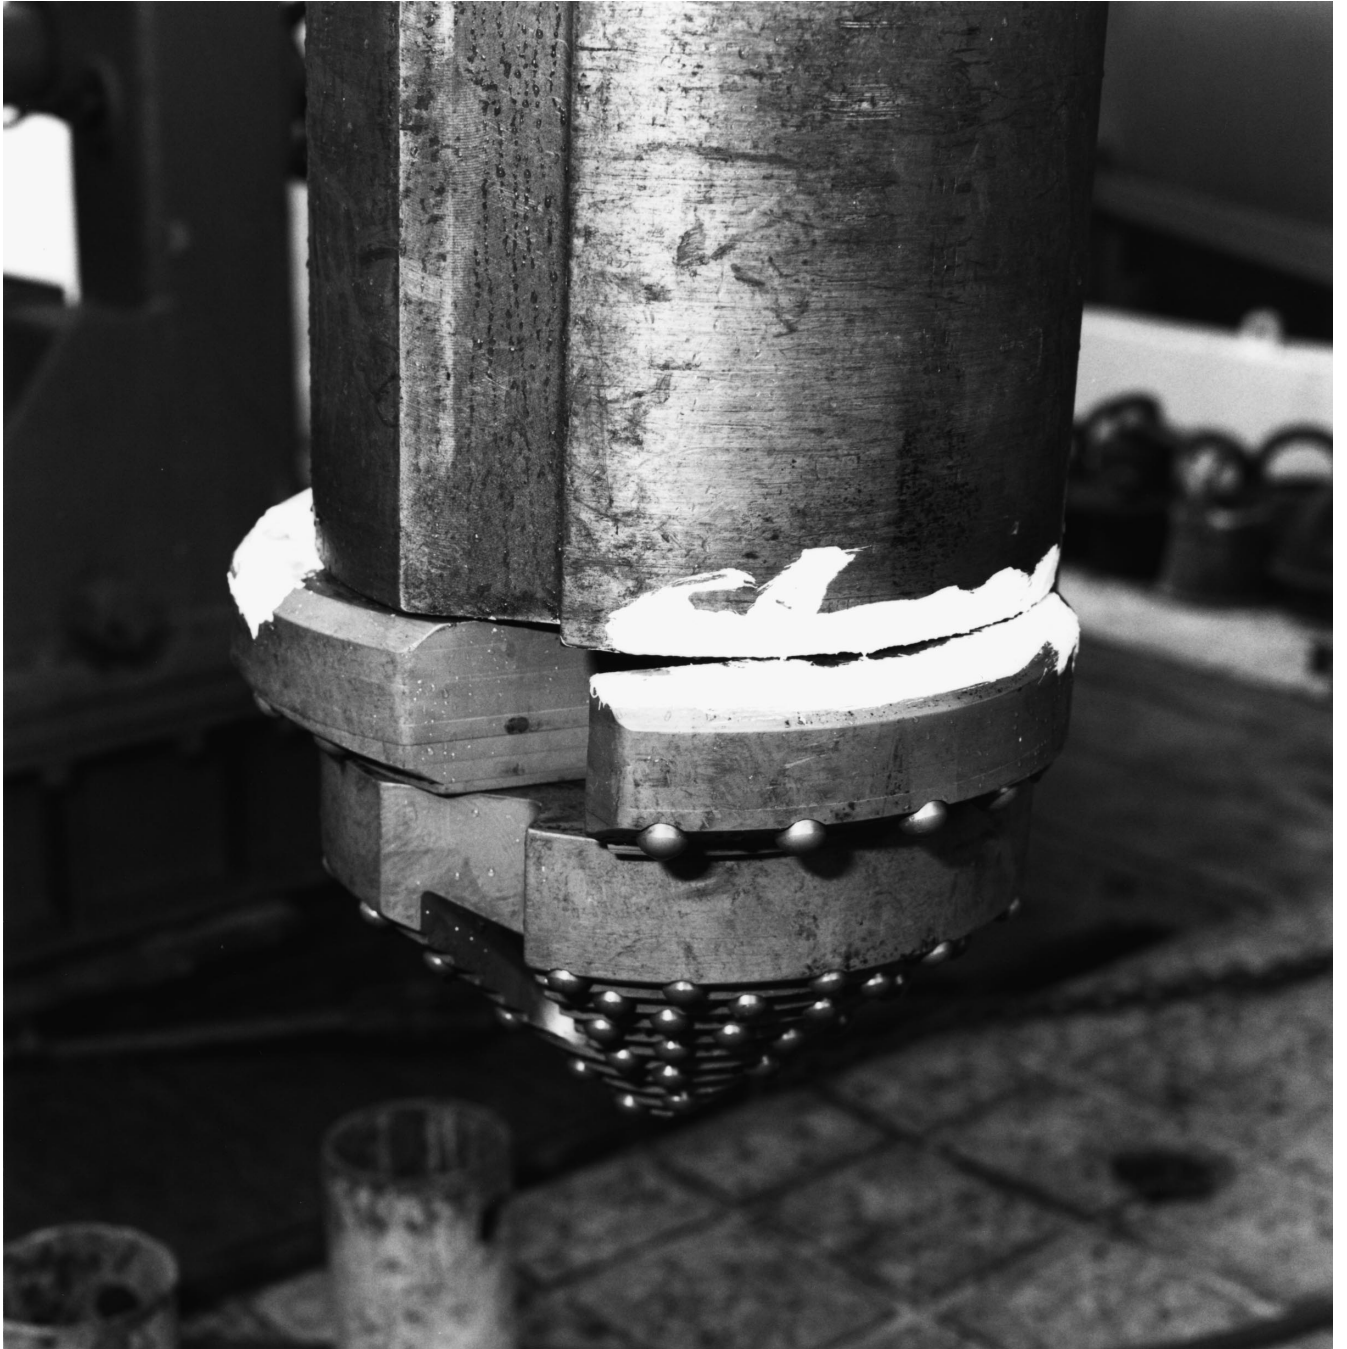
Figure 24

With the hammer and bit on deck at 2230 hr 12 May, an inspection was carried out. The Holte CUB had suffered much the same damage as did the SDS bits (Fig. 24). All of the TCIs on the underreaming arms, except for the last one on the trailing edges, were broken off. Also, four TCIs near the shoulder of the pilot bit were broken off as well. Disassembly of the hammer revealed the valve was cracked similarly to the first cracked valve. The other internal parts of the hammer appeared to be in good shape.

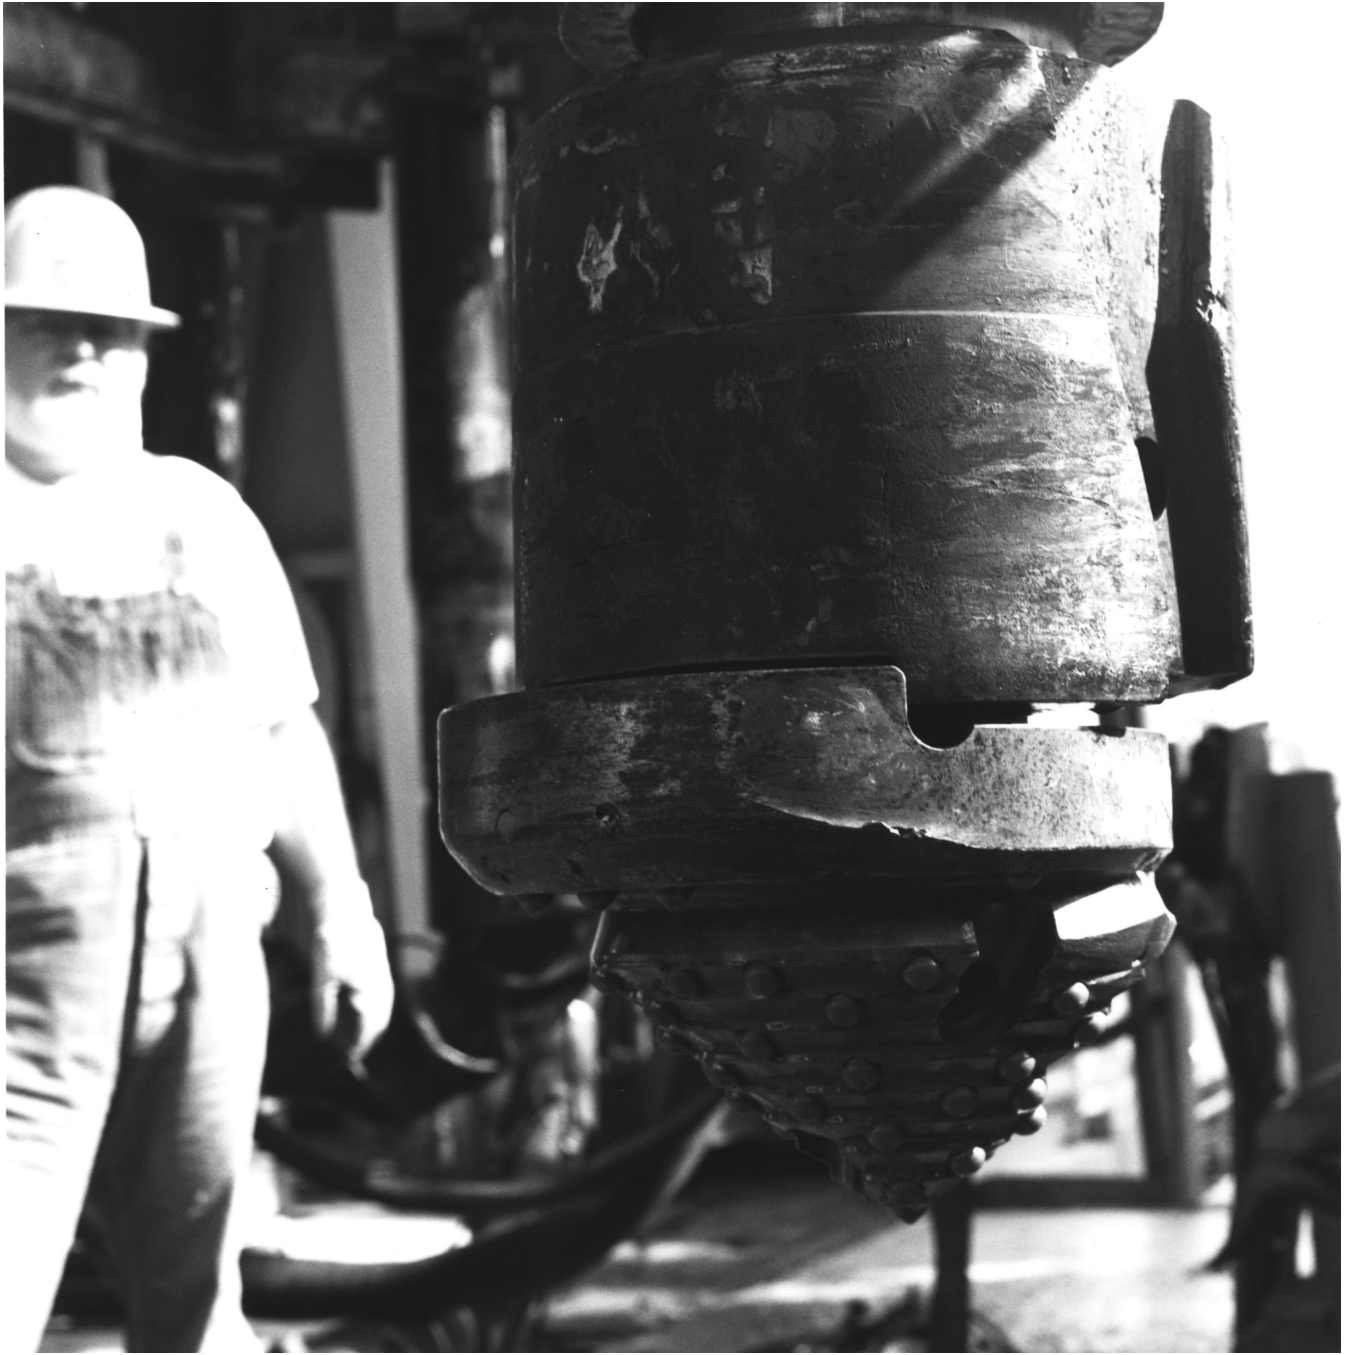
Figure 25

Inspection of the Holte EUB revealed similar wear patterns as observed on the concentric bits (Fig. 25). The outer edge of the eccentric was severely abraded and most of the TCIs on the outer edged of the

eccentric were broken. Several TCIs on the pilot bit shoulder were also broken. The EUB was determined not to be usable.

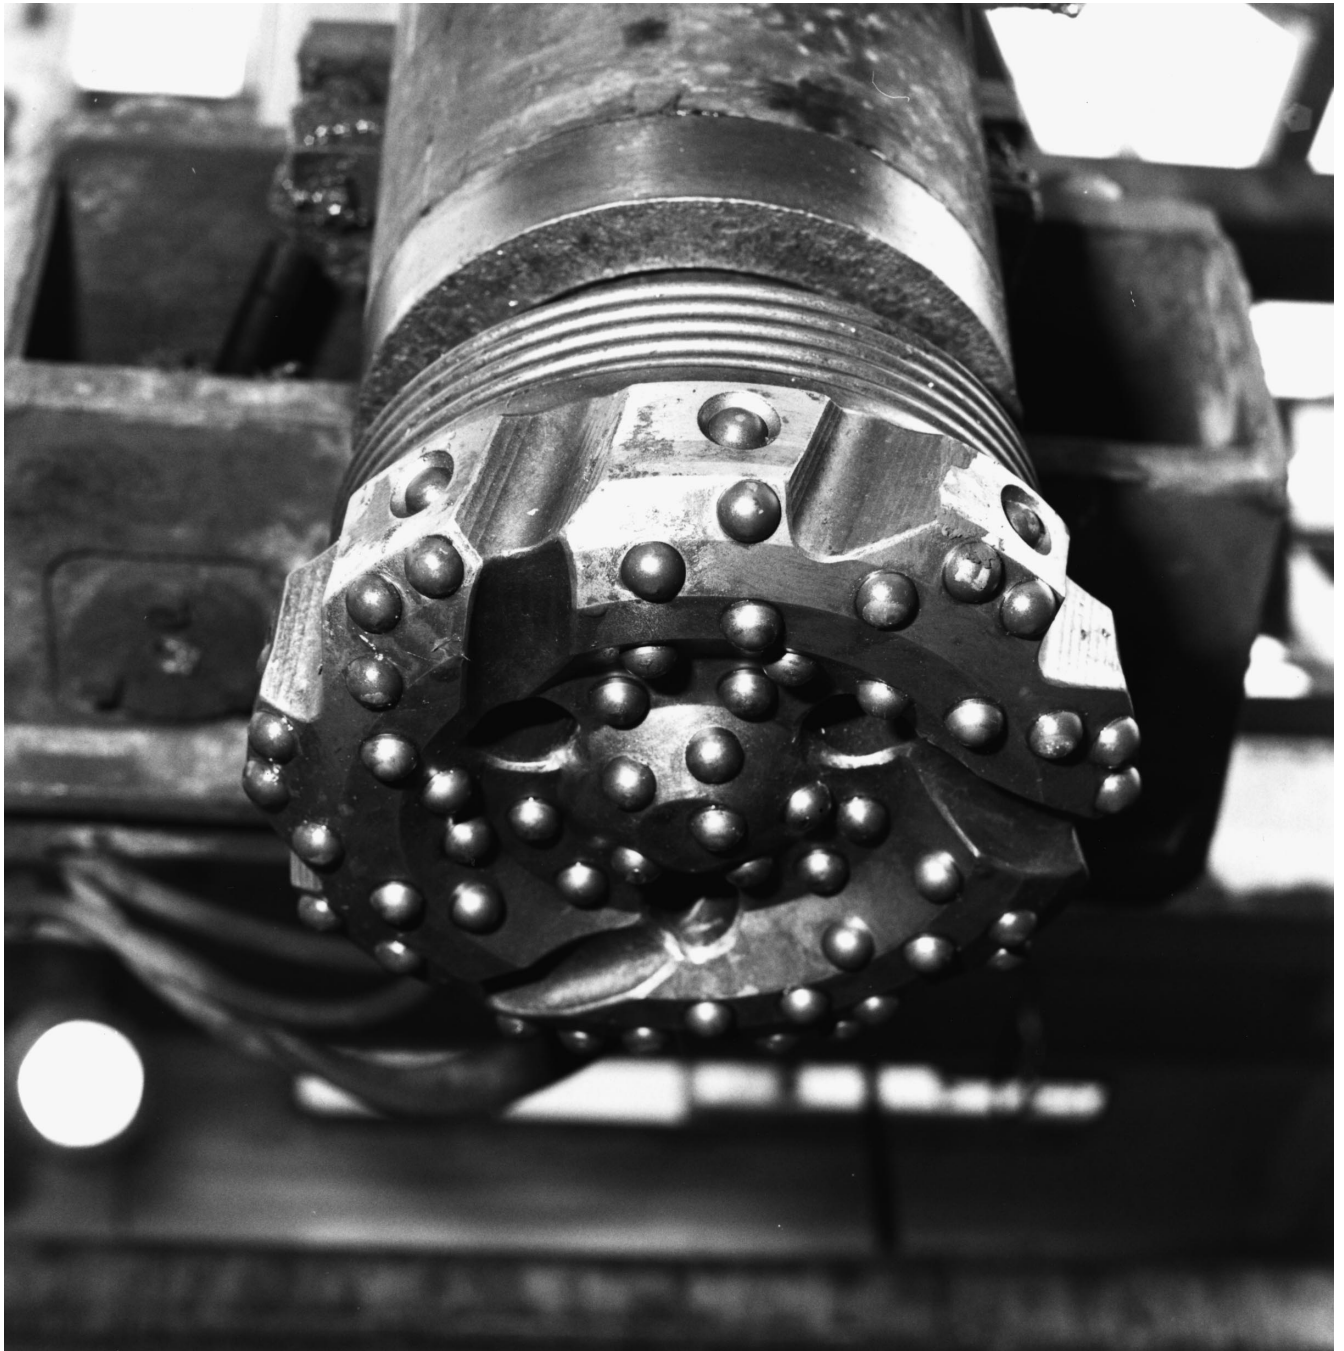
Figure 26

The SDS flat-face drill bit (Fig. 26) was the last hammer drill bit on board to test. Although the aim of the HDS is to drill in casing, which requires an underreamer bit, the drill bit was deployed in an effort to prove that (1) the hammer drill could drill hard rock and (2) it was the premature deterioration of the underreamer arms that was preventing deep penetration. In anticipation of a long drilling run, the hammer drill was disassembled and a new cartridge installed. The drill bit was attached to the refurbished hammer drill and the assembly deck tested. The hammer cycled perfectly and was run for ~2 min. We reduced the flow rate to 130 gpm and picked up the hammer to check the bypass, which opened as expected.
