## 6. DESIGN AND PERFORMANCE OF SUBSEA HARDWARE<sup>1</sup>

### EXECUTIVE SUMMARY

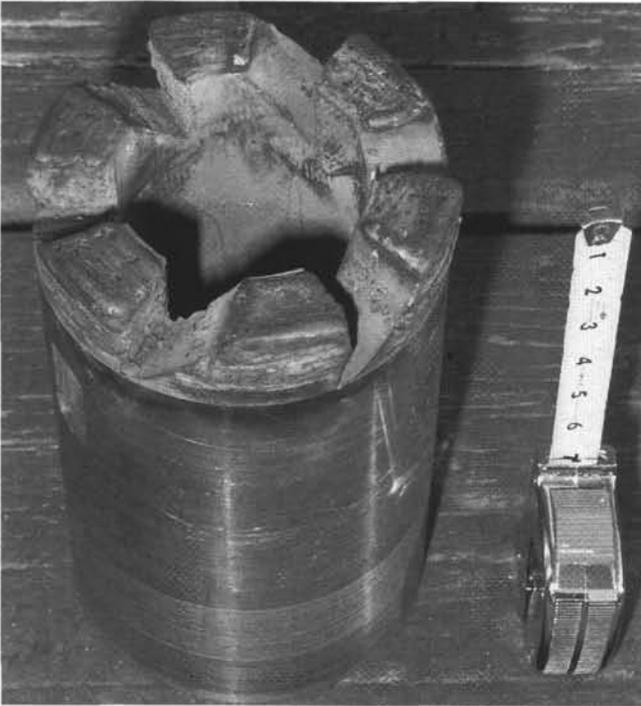
Figure 70. Modified 7-1/4-in. sawtooth bit.
