2. DEPLOYMENT AND TESTING OF THE DIAMOND CORING SYSTEM ON LEG 124E¹

Steven P. Howard²

OVERVIEW AND INTRODUCTION

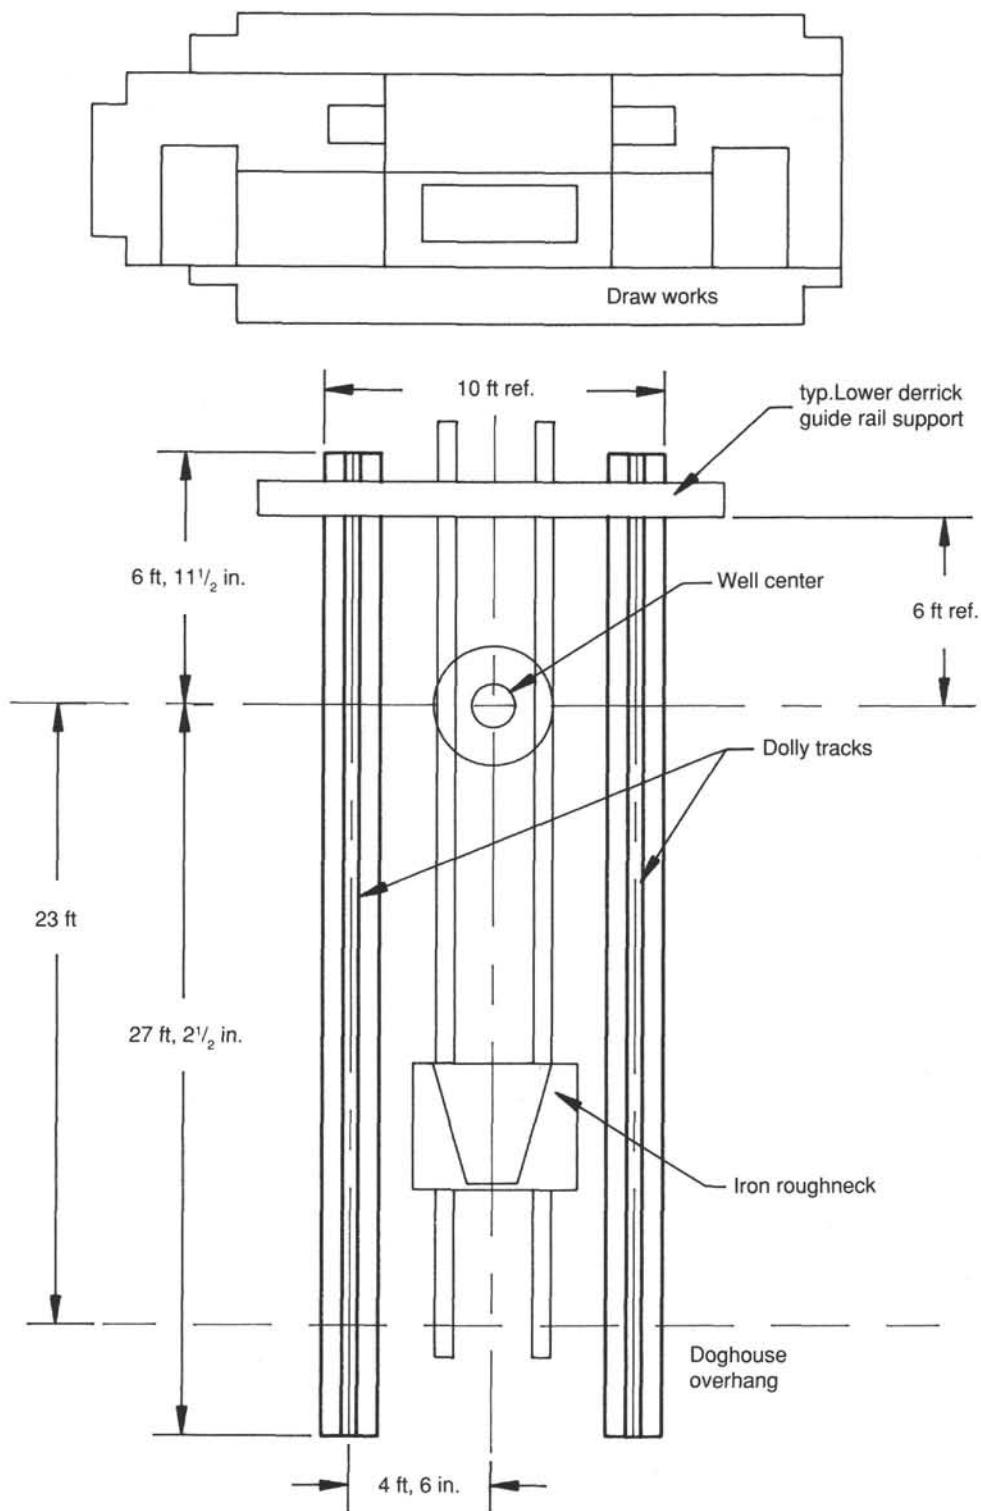
Figure 2. Plan view showing installation of dolly tracks on rig floor for DCS assembly.

The initial rig-up and assembly of the diamond coring system was done during the port call in Manila. The tracks for the DCS platform dolly were handled to the rig floor with the no. 3 crane. The tracks were spotted on the rig floor, shimmed, and welded in place (Fig. 2). The platform dolly was then placed on the rig floor in two pieces, assembled, and positioned on the tracks (Fig. 3). A total of 6 hr was required to assemble the tracks and platform dolly.

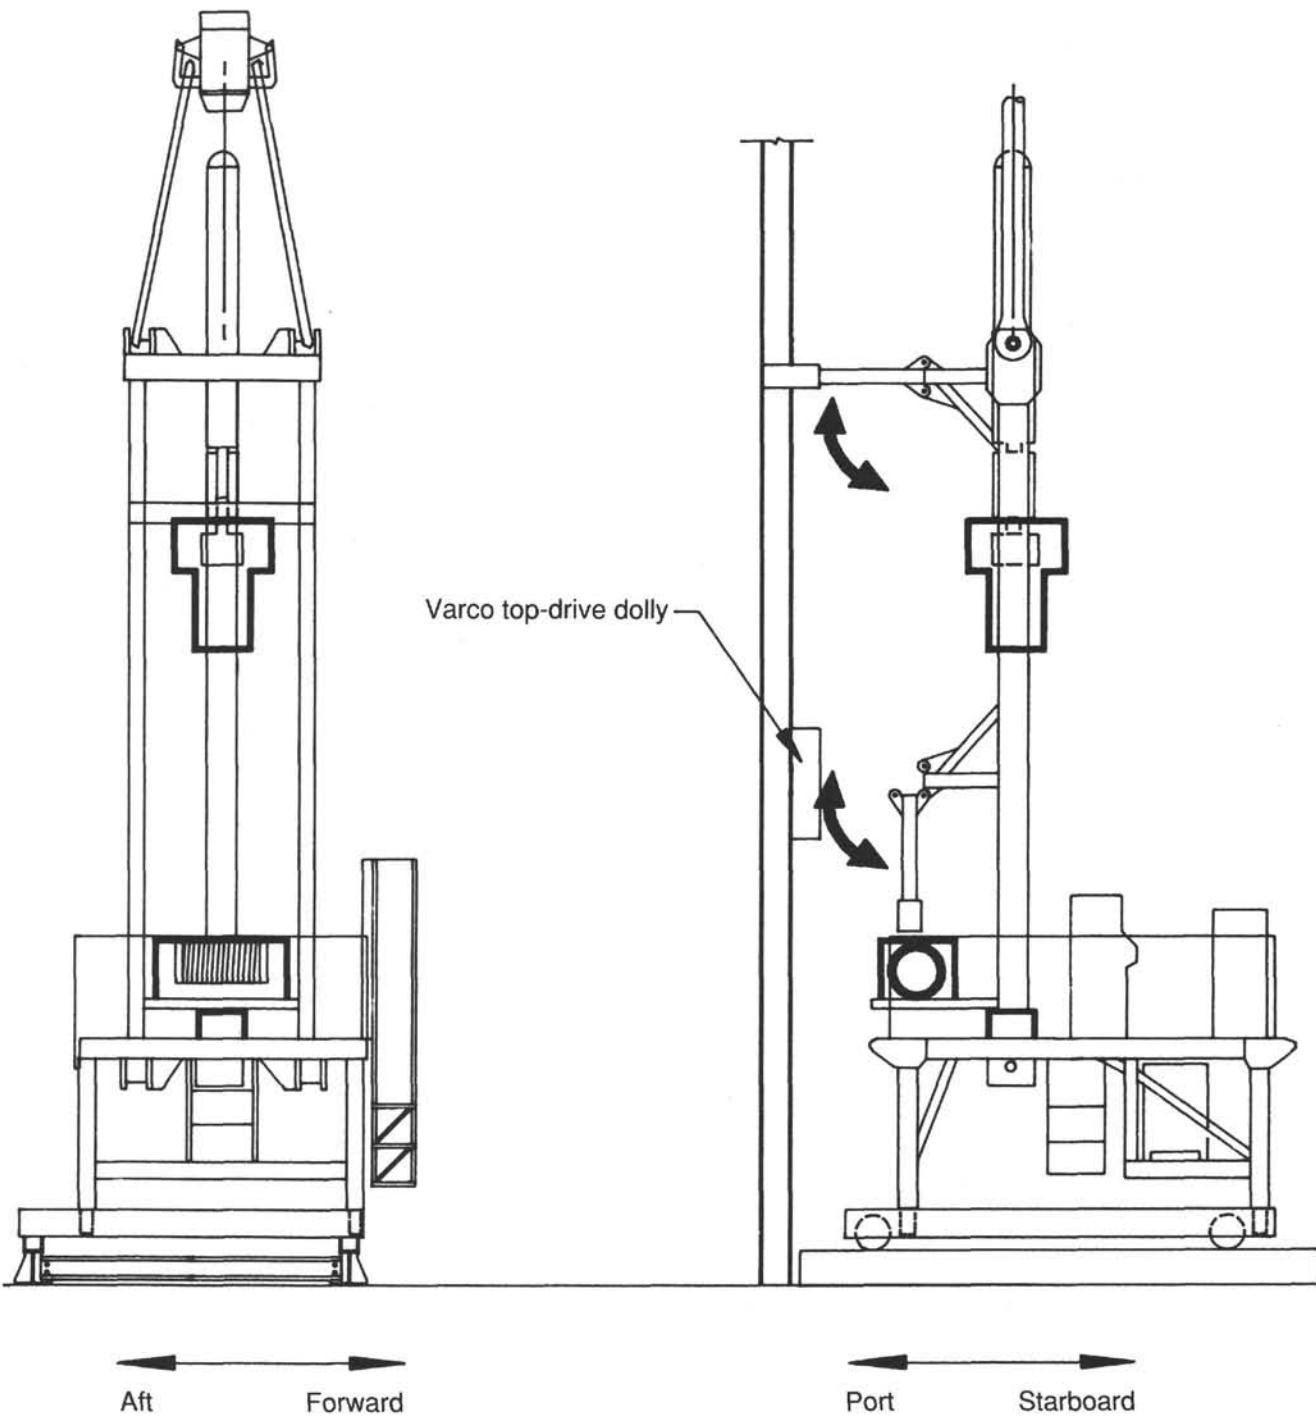
Figure 5. Right-angle views of mast installation for DCS assembly.

time required to rig the platform, mast, and upper mast dolly on the rig floor was 6 hr. While attempting to attach the lower mast guide dolly to the platform, we discovered an interference problem between the port-forward corner of the DCS platform and the Varco top-drive dolly. During the design phase of the DCS project this clearance was checked twice and found to be adequate, according to the latest derrick-modification drawings.

To correct the interference problem between the platform and the Varco top-drive hinges, it was necessary to modify the port-forward corner of the platform. A 13-in.² diagonal section was removed from the platform corner. To provide adequate

strength to the corner of the platform, a 4-in. I-beam and a 10-by 3/4-in. plate were welded across the diagonal. It was necessary to reposition the port-forward platform leg starboard of the newly installed diagonal structural member. Repositioning the leg necessitated repositioning and rewelding the port-forward platform dolly stabilization lug also. A total of 8 hr was required to make the modifications to the platform and plat-

form dolly. The modifications to the platform resulted in 6 in. of clearance between the Varco top drive hinges. Upon completing the platform modifications, the lower mast guide dolly was attached to the derrick guide rails.

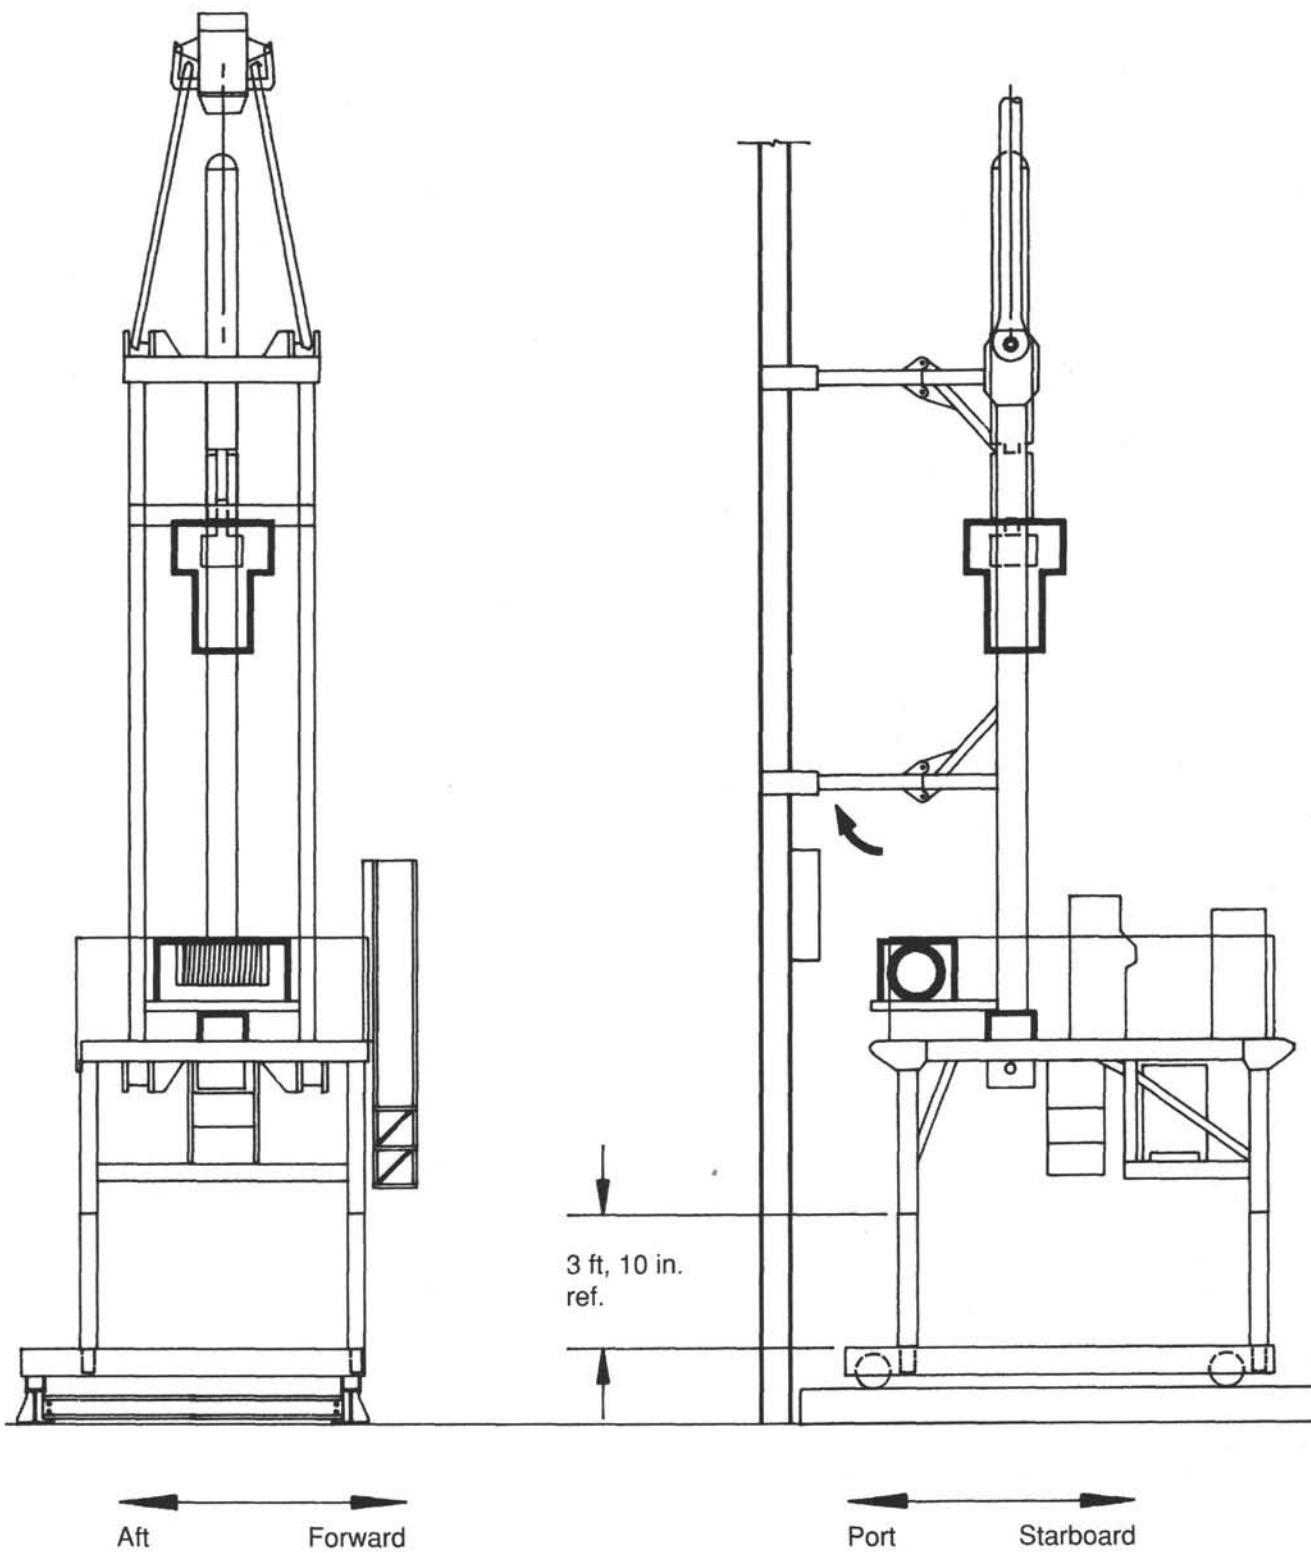
Figure 6. Right-angle views of upper mast guide dolly attached to DCS mast with legs extended.

cal position in the derrick (Fig. 5). The platform was skidded into position on well center using rig-floor tuggers. The mast was then stabbed into the platform roller guide box. The mast/platform lock-out pins were installed, and the shock cylinders were attached between the platform and mast. The draw works was found to have ample control for safely and precisely positioning the mast in the platform roller guide box, allowing proper alignment for installation of mounting pins and bolts. The upper and lower mast guide dollies were attached to the derrick guide rails. Using a tugger, the upper mast guide dolly was positioned in the derrick and attached to the DCS mast (Fig. 6). The

the DCS electrical umbilical assembly where it connected to the platform. A guard was installed to correct the problem. The bolts that hold the mast guide dolly roller assemblies in place were found to interfere with the splice in the derrick guide-rail tracks. The bolts were ground down to provide the required clearance. A potential interference problem between the platform/intermediate racking board fingers and the rig traveling equipment hose umbilical was identified. The fingers were cut by 10 in. to avoid their being hooked by the service hoses.

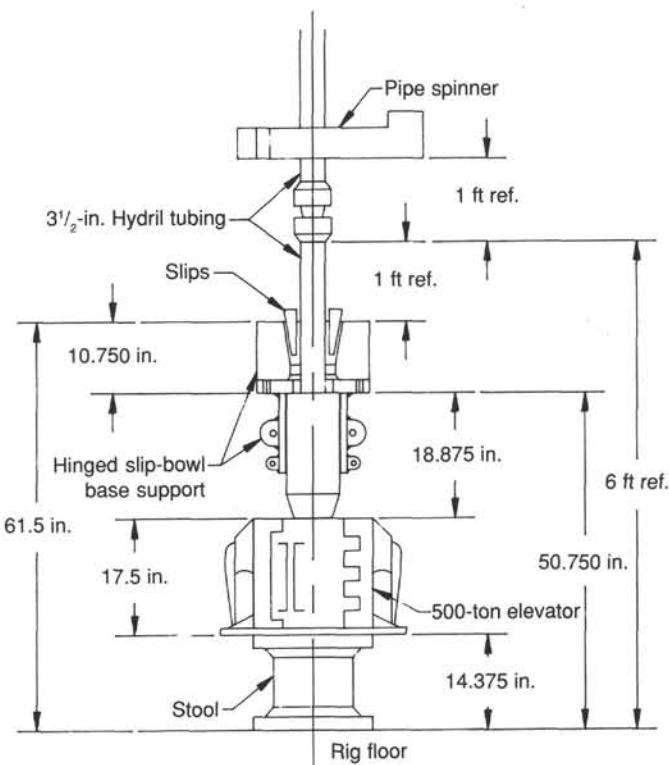
Figure 11. Diagram of rig-floor configuration for tripping 3 1/2-in. tubing.

Upon completion of the space-out, the rig floor was set up to trip the 3 1/2-in. tubing into the hole (Fig. 11). The iron roughneck was removed from the rig floor and stored on the main deck. The time required to prepare the rig floor for tripping the tubing was 3 hr. The Baash-Ross TS100 slip bowl and slip-bowl support were positioned on top of the 5 1/2-in. drill-pipe joint, hung off on the 350-ton elevators on the rotary. Originally, the tubing slip-bowl support was designed to rest on the 5 1/2 I.F. connection shoulder face. It was determined that there was adequate bearing support on the top surface of the 350-ton elevators to support the slip-bowl support without having to rest on the 5 1/2 I.F. connection face. Using the Weatherford tubing power tongs and a Kelco manual tong for back-up, the tubing was tripped in the hole. Tripping platforms were used to compensate for the tubing slip-bowl stack-up at the rig floor (Fig. 12). The tubing was handled efficiently from the tripping platforms, with no difficulty encountered in making up the Hydril connections with the power tongs. The XCB bit was positioned 1697.9 m total depth from the rig floor. The tubing and DCS core bit were positioned at 1681.5 m (approximately 16 m from the end of the XCB bit face) total measured depth from the rig floor. With the XCB bit positioned in the bottom of the hole, the measured depth from the rig floor to the bottom of the

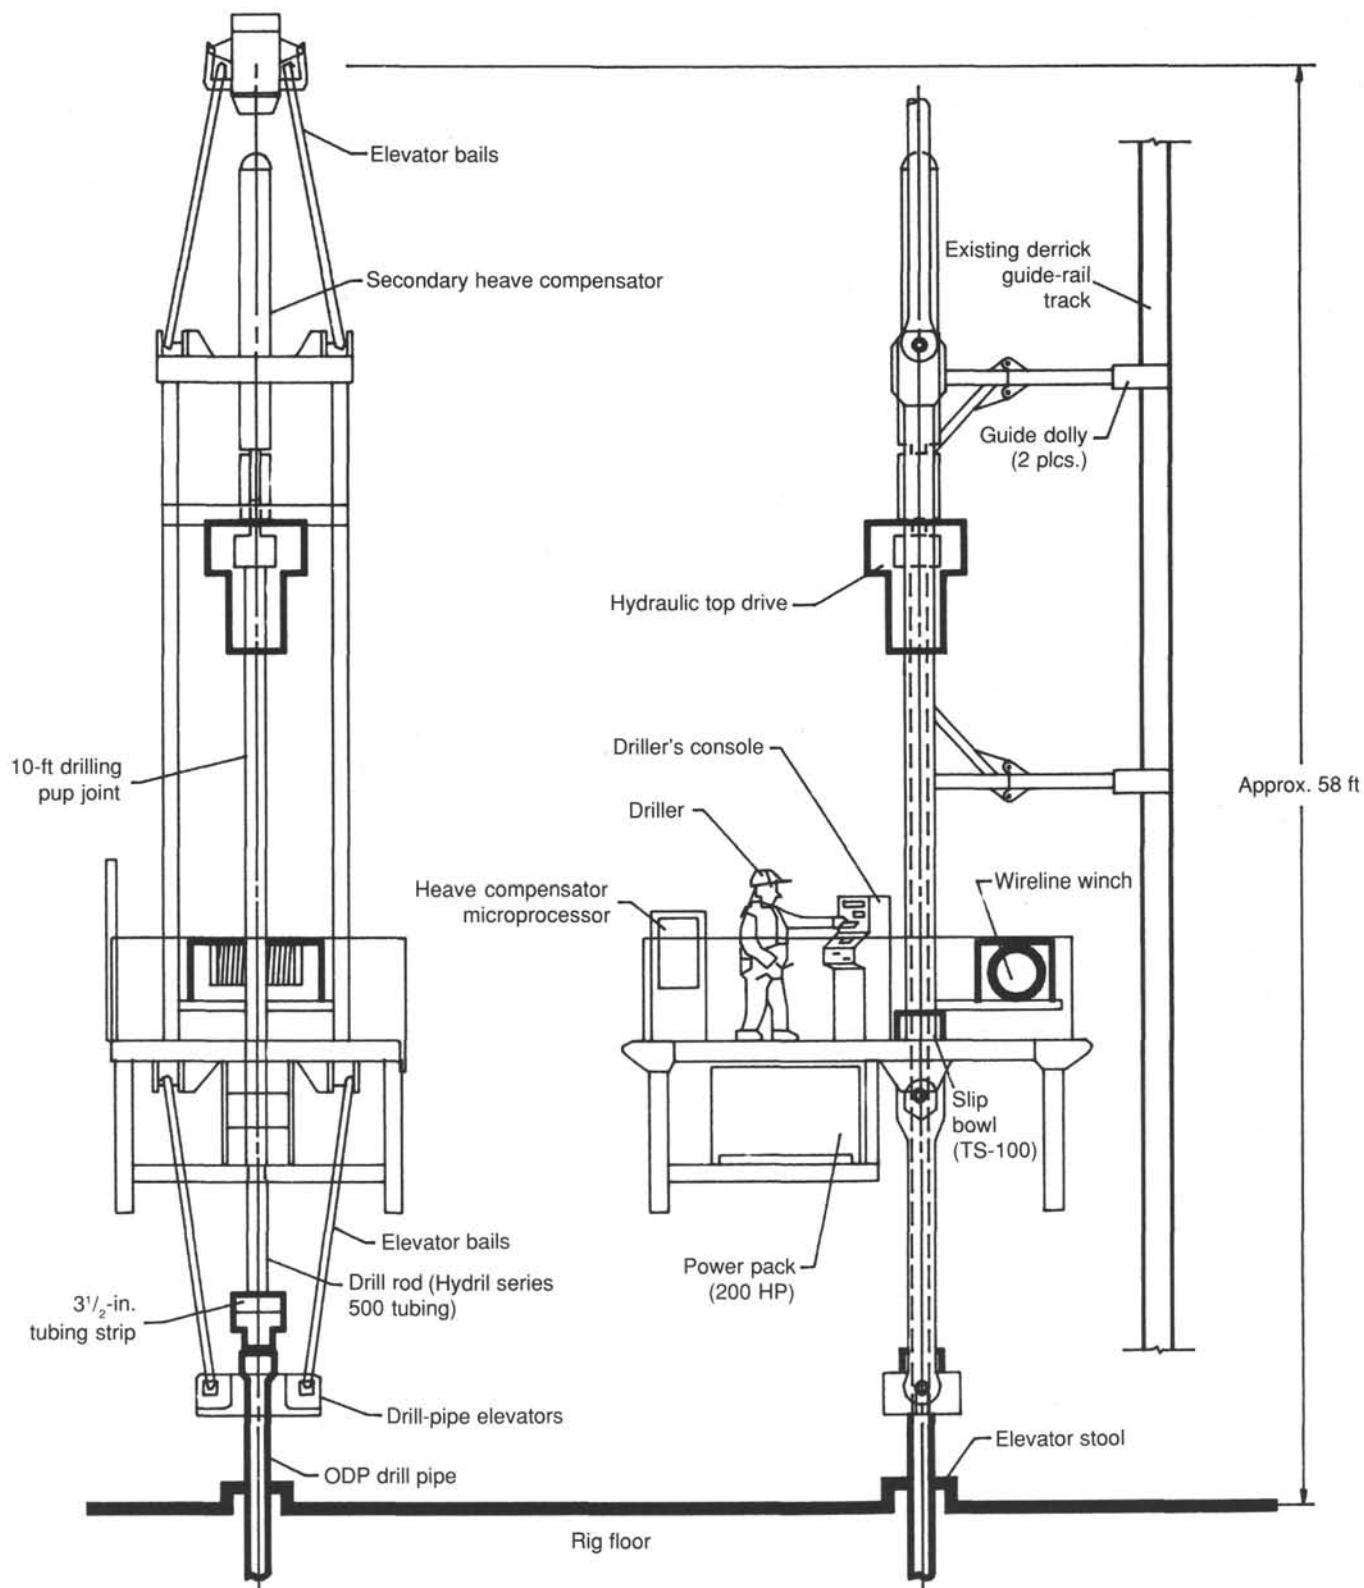
Figure 14. Diagram of major DCS components, showing platform configuration.

Described in this section are evaluations of major components of the diamond coring system following deployment on Leg 124E (Fig. 14). Reflected in the descriptions are modifications and considerations for the future.

No major operational problems were encountered with the DCS power pack. During one of the core-bit runs a fluid-supply hose to the wireline winch vibrated loose, resulting in 30-40 gal of hydraulic oil being lost. During night operations it is very difficult to detect a leak, since the reservoir gauge is located below the DCS platform floor. The crew member must get in a riding belt and go over the side of the platform to check the fluid level. To aid the driller in monitoring the levels in the hydraulic reservoir, a gauge and alarm (indicator light) should be installed on the driller's console. Sound-proofing the platform floor would enhance communications by telephone between personnel on the platform and rig floor. The presence of over 100 gal of hydraulic oil and a high-voltage, high-current 200-hp electric motor poses an extreme fire hazard. A marine-grade explosion-proof motor definitely should be installed. Owing to the platform's being 45-75 ft in the air, evacuation of personnel using tuggers and riding belts would likely be slow. Thus, in the event of a fire it would be difficult to remove personnel rapidly from the platform. A safeguard foam-type automatic fire-extinguisher system should be installed. To further protect personnel on the platform, fireproof panels should be installed in the floor of the platform. Some type of emergency rope ladder that could be lowered over the side of the platform for rapid evacuation should also be installed.

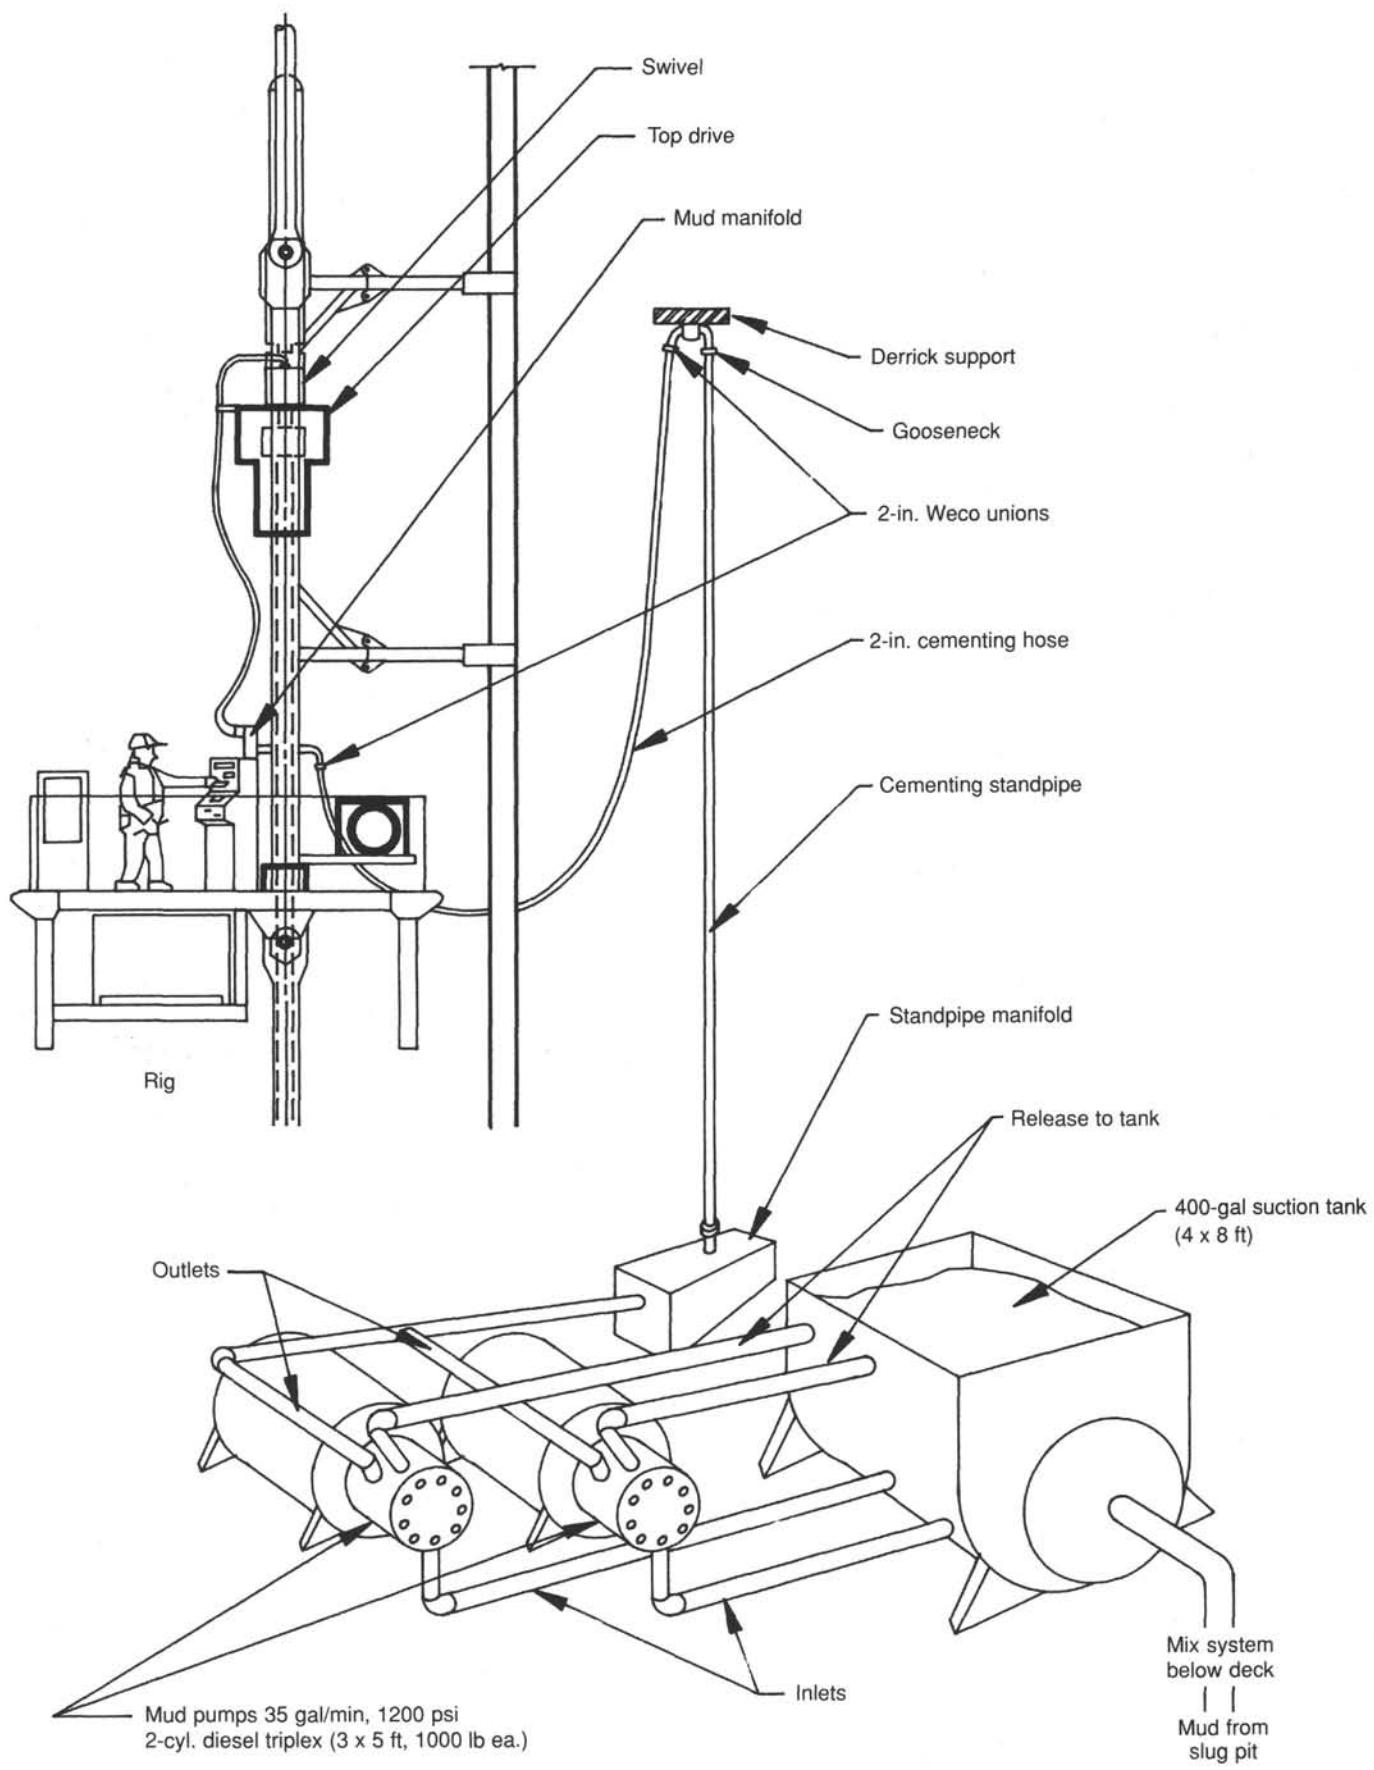
Figure 15. Diagram showing DCS circulating system.

The DCS mud-pump system was set up on the starboard aft side of the rig floor (Fig. 15). The system was tied into the ce-

menting standpipe and circulating standpipe manifold on the rig floor. Mud was premixed in the slug pit and pumped up to the DCS circulating pit on the rig floor. The circulating system worked well with the exception of no pump-system control on the platform. If it was required to stop the pumps or change a flow rate, the driller had to call the rig floor and have someone attending the pumps on the rig floor make the change. Control of the pumps needs to be on the DCS platform to give the driller control while coring as well as for safety considerations. A dedicated blowdown line back to the rig floor is required to prevent dumping water on personnel and equipment on the DCS platform and rig floor.
