OCEAN DRILLING PROGRAM
LEG 137 PRELIMINARY REPORT
HOLE 504B CLEANOUT

May 1991

Preliminary Report No. 137

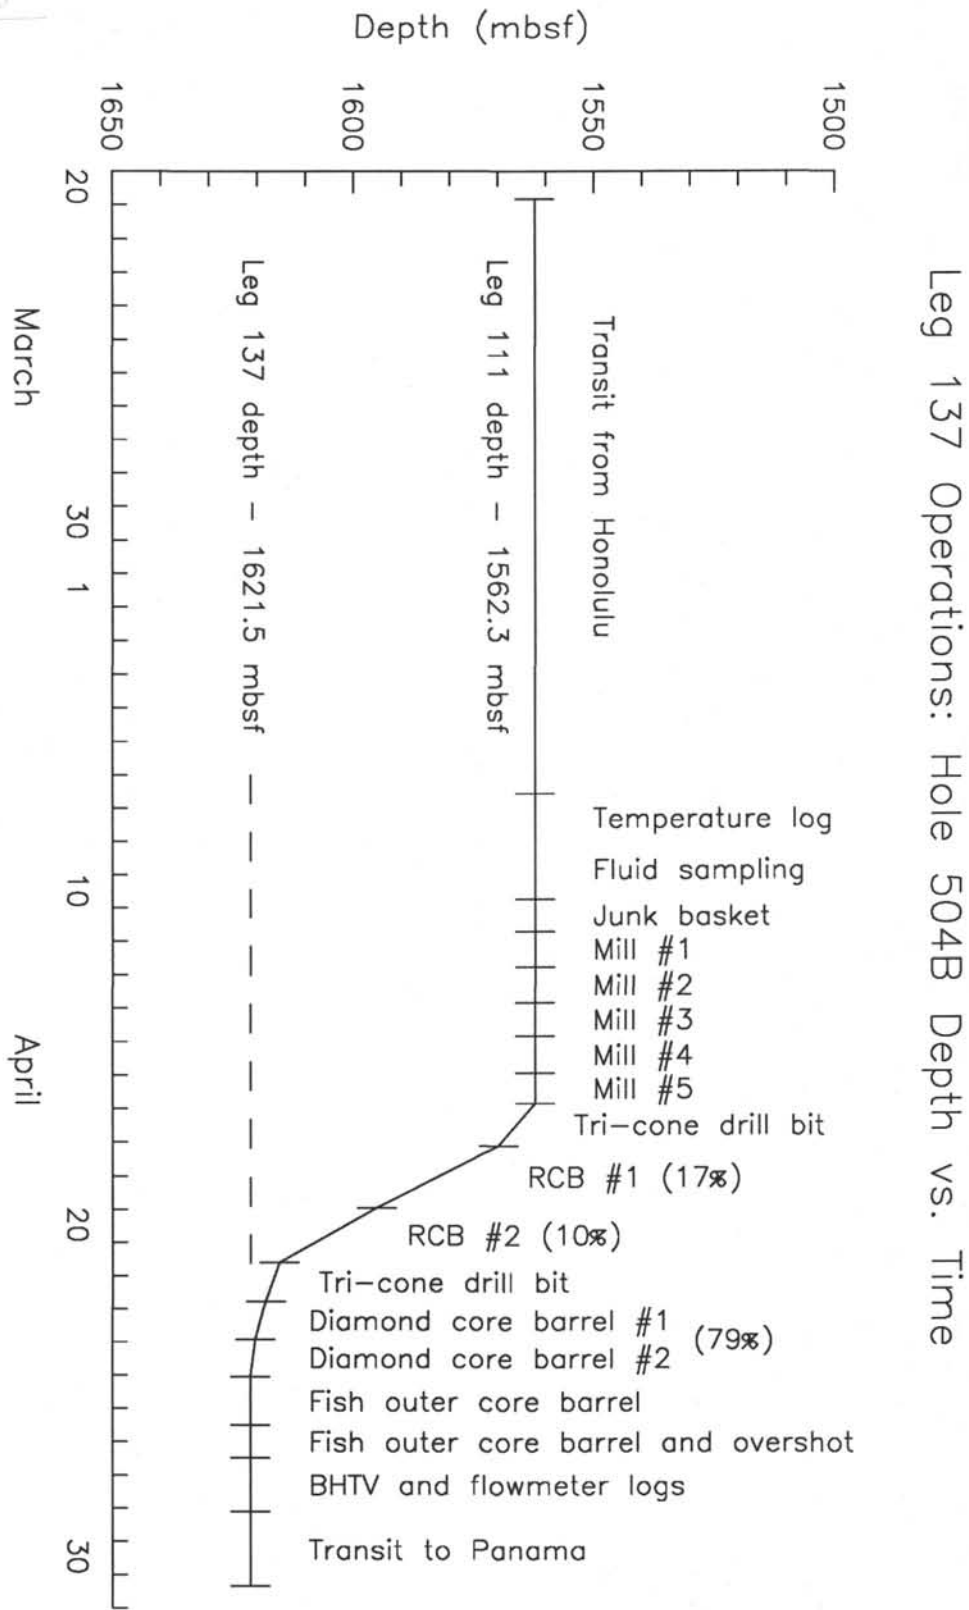
Despite these uncertainties, Leg 137 was able to run straight to the junk from virtually the beginning of remedial operations. Cleaning the junk from the bottom of the hole required less than one week of straightforward operations (Fig. 4), including one fishing attempt with a junk basket and five mill runs with boot baskets to capture pieces of broken-up metal. These returned with parts or whole pieces of all the lost hardware, including recognizable pieces of the diamond bit. This was followed by a run with a tri-cone drill bit to verify that the hole was clean, which deepened the hole without coring by 8 m to a total depth of 1570 mbsf.

Figure 4. Summary of Leg 137 operations, showing depth of Hole 504B vs. time during the leg.

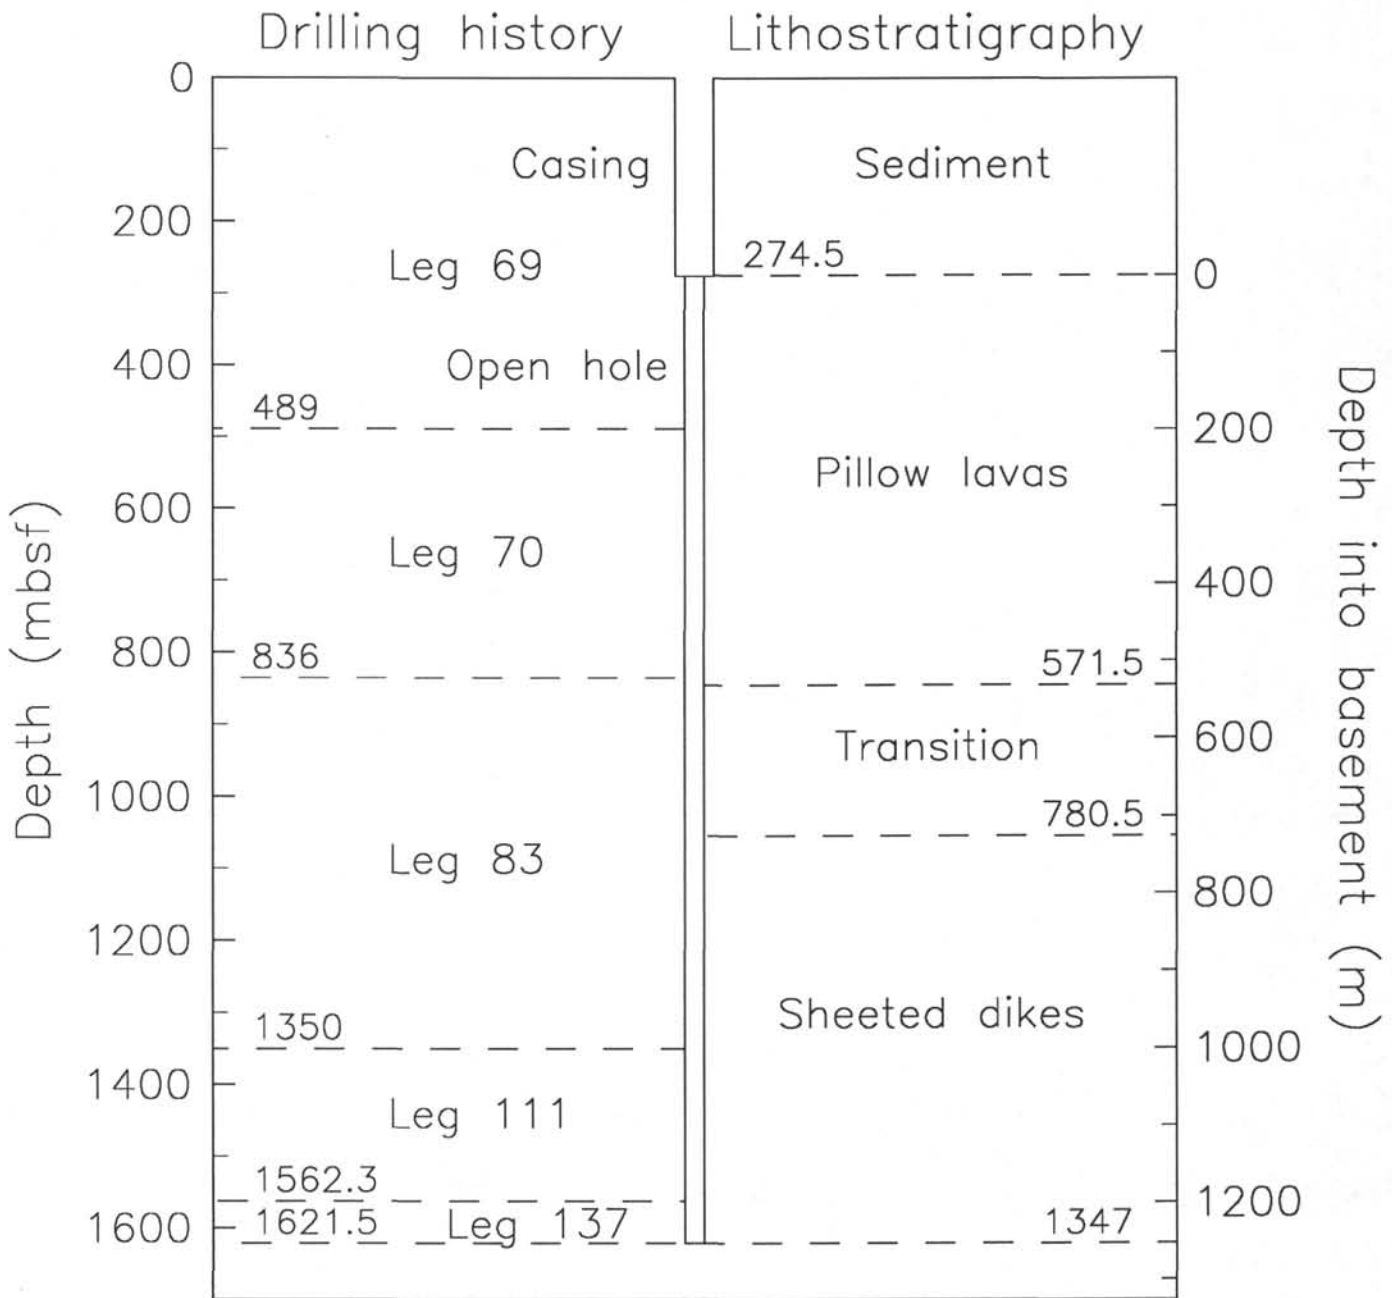
Drilling on Leg 137 deepened Hole 504B by 59.2 m to a total depth of 1621.5 mbsf or 1347 m into basement (Fig. 6). Of this interval, 48.6 m was cored, with a recovery of 8.77 m. The recovered rocks are all interpreted as a continuation of the sheeted dike complex, although no intrusive dike margins were actually recovered. The physical properties of recovered core support the inference that the formation is very hard and dense massive basalt, and therefore difficult to core. Chlorite and actinolite veins and actinolite-bearing alteration halos are common in the diamond cores with good recovery. It would therefore appear that the trend of increasing proportion of actinolite in the secondary mineral assemblage recognized on Leg 111 continues with depth.

Figure 6. Schematic of drilling history and lithostratigraphy of Hole 504B as of the end of Leg 137.
