2. ADVANCES IN HARD-ROCK DRILLING AND CORING TECHNIQUES, ODP LEG 118¹

Steven P. Howard²

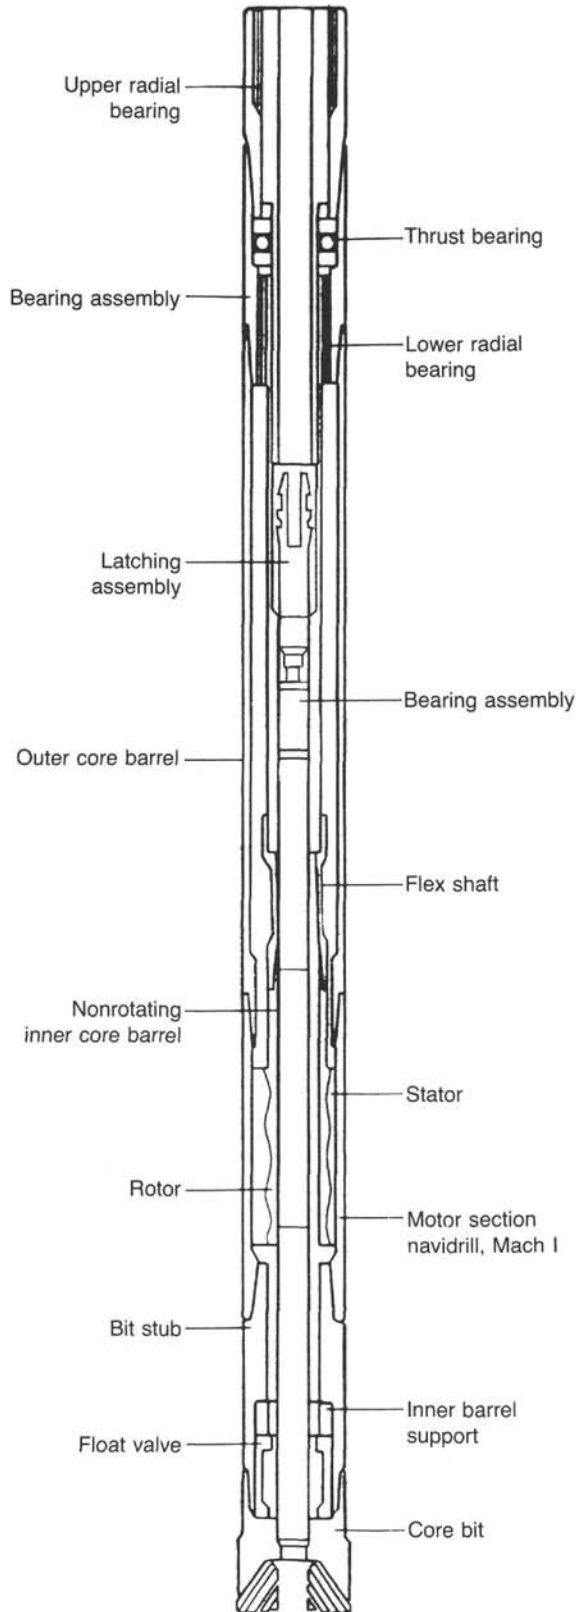
Figure 1. Diagram of the 9.5-in. positive displacement coring motor.

Twelve shallow holes were spudded at Sites 732, 733, 734, and 735 using Eastman Christensen's 9.5-in. positive displacement coring motor (PDCM). The PDCM provides up to 6000 ft-lb of torque at 90 to 120 rpm. Flow rates of 400 to 600 gal/min are required to rotate the motor downhole. A 30-ft core barrel, run in on wireline, is landed in the hollow rotor section of the motor. This rotor is connected to the drill string through the drive sub assembly. As fluid passes across, rotor and stator torque is generated. This torque rotates the 40-ft-long outer motor housing, which in turn induces torque and rotation to the 10.5-in. outside diameter × 2.25-in. roller-cone core bit. After cutting a 30-ft cone, the core barrel is retrieved by wireline, completing the coring cycle (Fig. 1).

The bearing-drive subassembly held up well during the difficult spudding operations encountered during Leg 118. PDCM M148 was rotated downhole for 95 hr and motor M147 was rotated for 49 hr (Fig. 1). Longitudinal bearing play was 0.120 in. for motor M148 and 0.107 in. for motor M147. Both motors had 0.0709 in. of bearing play before being run downhole. All coring was performed with the PDCM using an unsupported BHA. Use of unsupported BHAs increases significantly the load on the bearings, compared with loads in conventional drilling. We consider the low amount of observed bearing wear as good. Not only is the new longitudinal bearing design superior from the standpoint of wear, but this design adds considerable strength to the drive subassembly.

The failure of the pin connection on the bit sub of motor M148 was attributed to the unusually high bending and torsional stresses associated with unsupported coring operations. To increase the strength of the bit sub, the inside bore diameter of the Hycalog pin connection could possibly be reduced by 0.250 in. This, coupled with increasing the strength and toughness of the bit-sub material, should enhance the strength of the bit sub considerably. However, one then would have to modify the diameter of the float valve to fit into the reduced bore of the bit sub (Fig. 1).

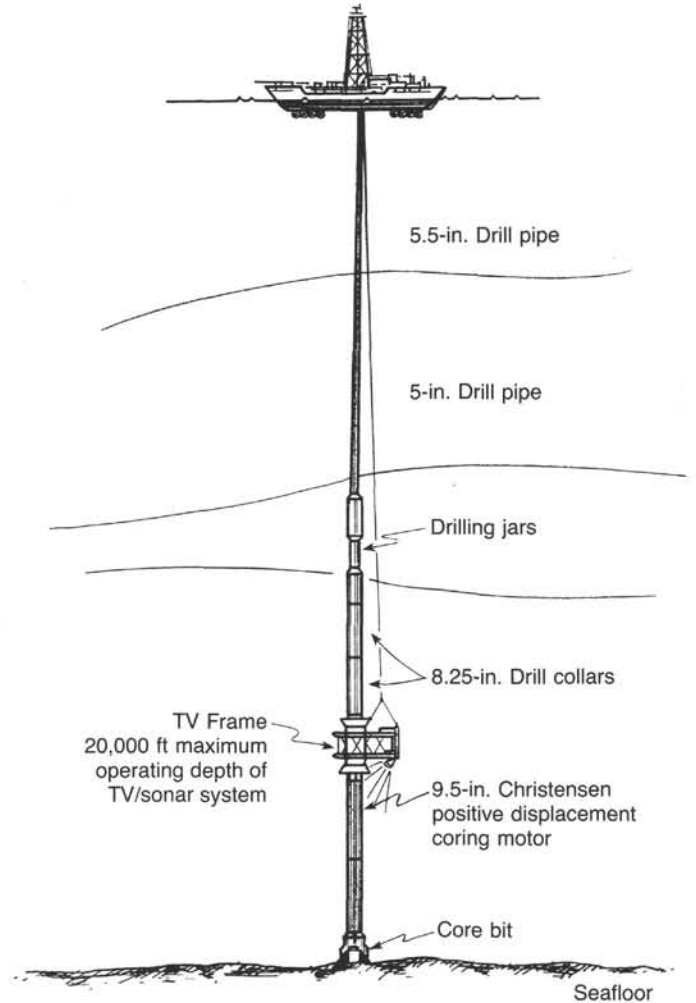
Figure 2. Diagram of the 9.5-in. positive displacement coring motor showing the unsupported bottom-hole assembly.

and reliably with an unsupported BHA (Fig. 2). We lost no BHAs during operations using the PDCM. Before the advent of PDCMs, many BHAs were lost while attempting to spud bare-rock sites during the Deep Sea Drilling Project.

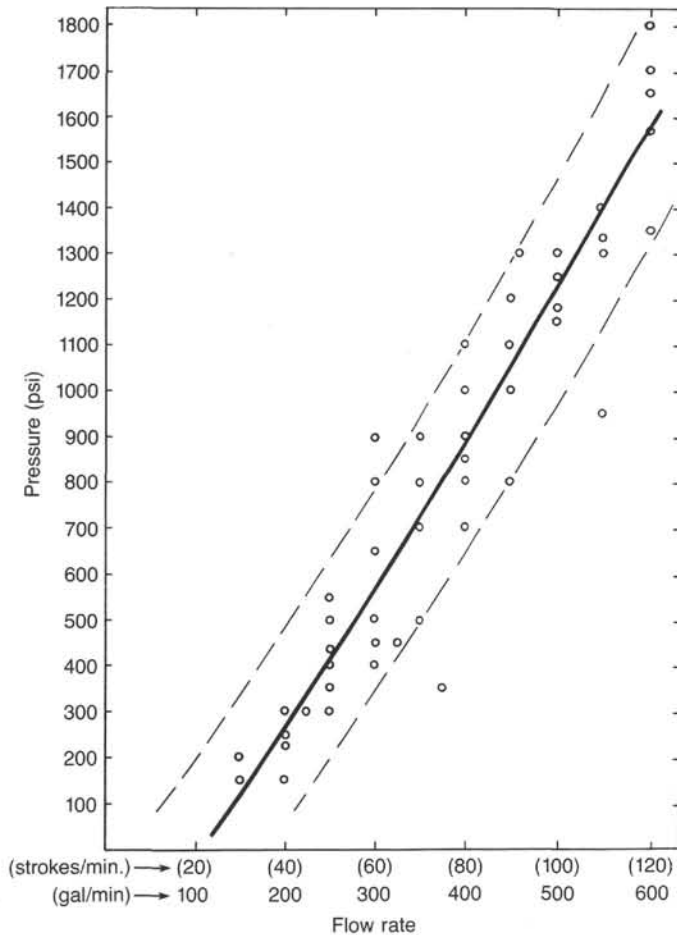
Figure 3. Plot of 9.5-in. Eastman Christensen coring-motor operating pressures as a function of flow rate. Parameters for Sites 732 through 735: weight on bit fluctuation = 1,000–10,000 lb; surface heave = 2.5 ft; heave period = 4.5; average water depth = 3800 m. Dashed lines = operating limits; dots = data points; solid lines = best-fit lines.

Figure 3 shows operating pressure as a function of flow rate. The graph reflects a spread of operating pressures observed while conducting unsupported coring operations in a number of exploratory holes. Drilling parameters were (1) 1000 to 10,000 lb

weight on bit, (2) 2.5-ft average surface heave (as measured by the heave compensator position indicator), (3) 4.5-s average wave period, and (4) an average water depth of 3800 m. Data were taken while working at Sites 732 through 735.

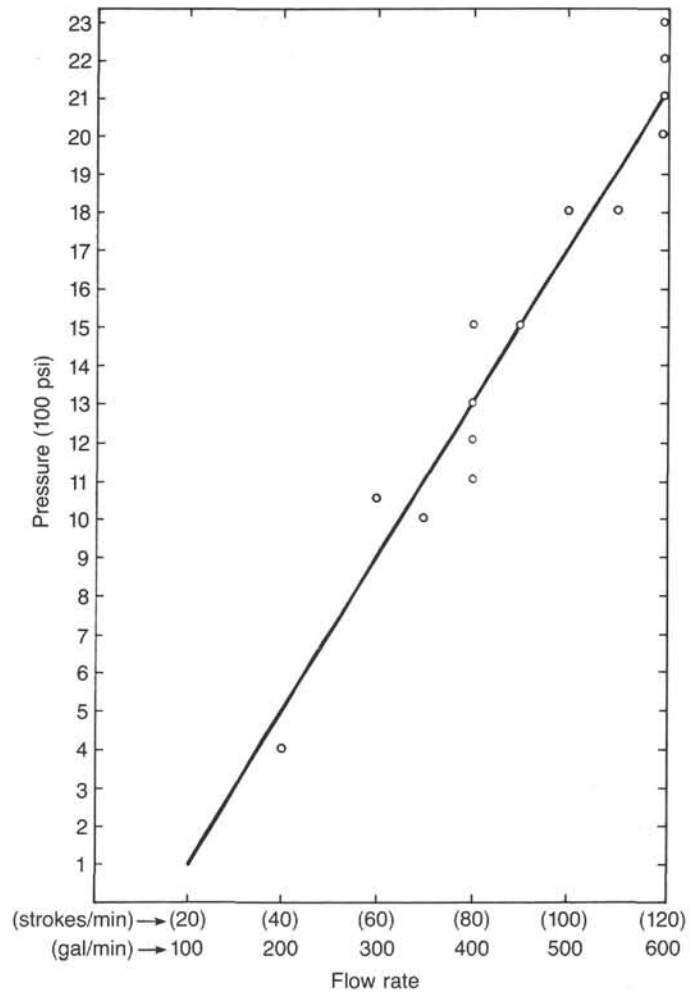
Figure 4. Plot of 9.5-in. Eastman Christensen coring motor stall pressures as a function of flow rate. Parameters for Sites 732 through 735: weight on bit fluctuation = 1,000–10,000 lb; surface heave = 2.5 ft; heave period = 4.5; average water depth = 3800 m. Solid lines = best fit line; dots = data points.

Figure 4 reflects stall pressures as a function of flow rate. The driller can compare real-time flow rates and operating pressures to both curves to ascertain if the coring motor is rotating properly downhole.

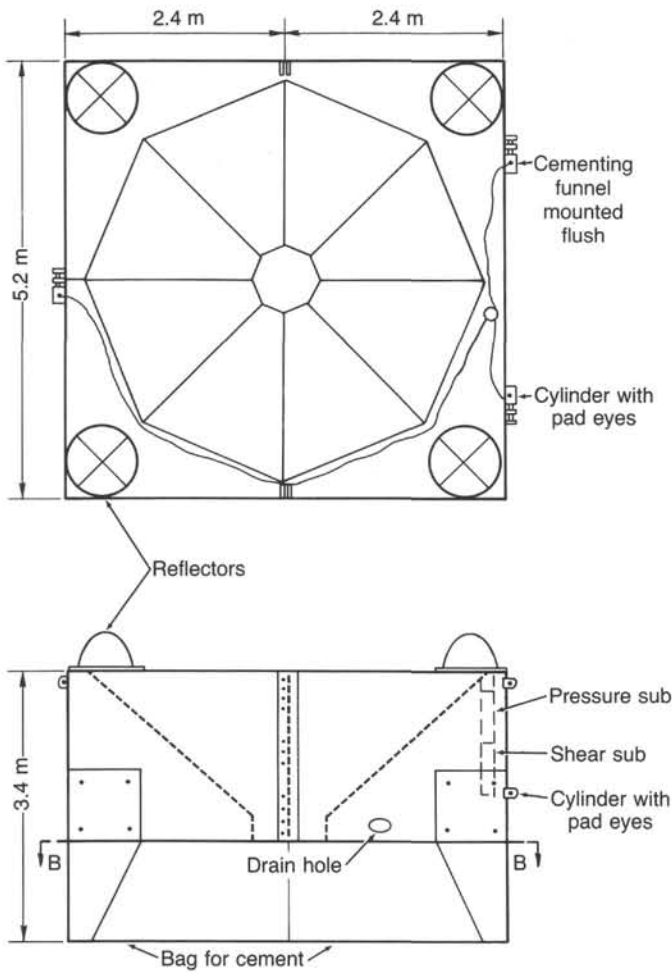
Figure 5. Top and side views of the HRGB. The 18,000-kg guidebase stands on four legs, is 5.2 m square, and 2.3 m high. The cone inside the guidebase is 26 ft (4.9 m) in diameter and 6 ft (2.8 m) deep (after Shipboard Scientific Parties, 1988).

Details of the hard-rock guidebase (HRGB) assembly and deployment (Fig. 5) have been described by the Leg 106/109 Shipboard Scientific Party (1988). Additional details are given in the ODP in-house engineering assembly and operations manual. During Leg 118, the HRGB was assembled, deployed through the moon pool, manipulated from vertical to horizon-

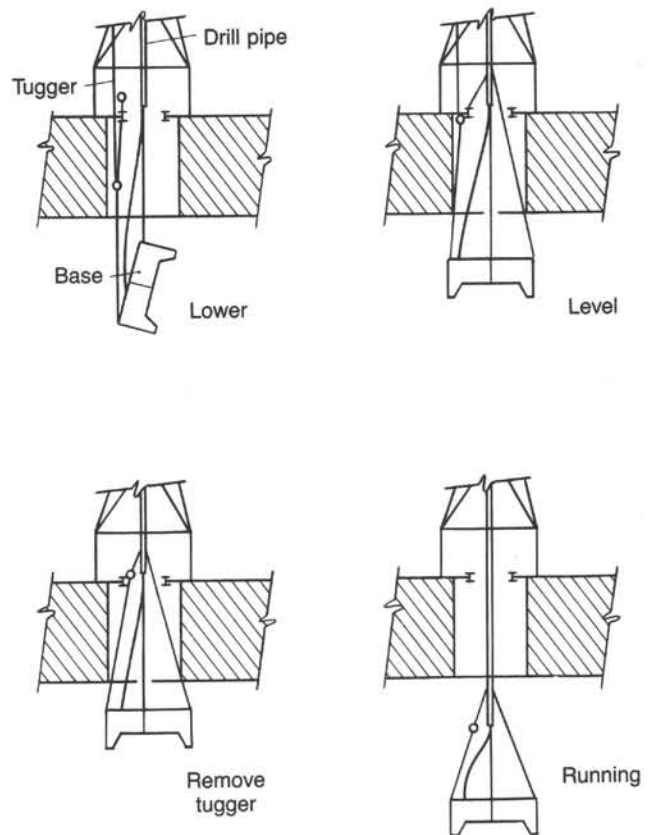
Figure 6. Diagrams showing steps for HRGB deployment (from Shipboard Scientific Parties, 1988).

tal below the keel, and reassembled, and the rig floor was prepared for tripping the guidebase to the seafloor in a total of 18.75 hr (Figs. 6 and 7). Of this, 5 hr was required to disassemble and reassemble the rotary table plug. The time taken to lower the HRGB 734 m to the seafloor, to space out the drill pipe in preparation for its landing on the seafloor at Site 735 (Hole 735B), to pick up the cementing head, and to land it on the seafloor required 4.5 hr. Actuating the pressure sub, pumping 1864 ft³ of 15.5 lb/gal cement, and releasing the kelly hose from the HRGB took 4.75 hr. Total time required to assemble, run, release, and cement the HRGB on the seafloor was 28 hr. The total time of deployment from the time the first half of the HRGB was picked up and handled through the rig floor, until the first reentry in the HRGB with the unsupported coring motor assembly, was 43.5 hr.

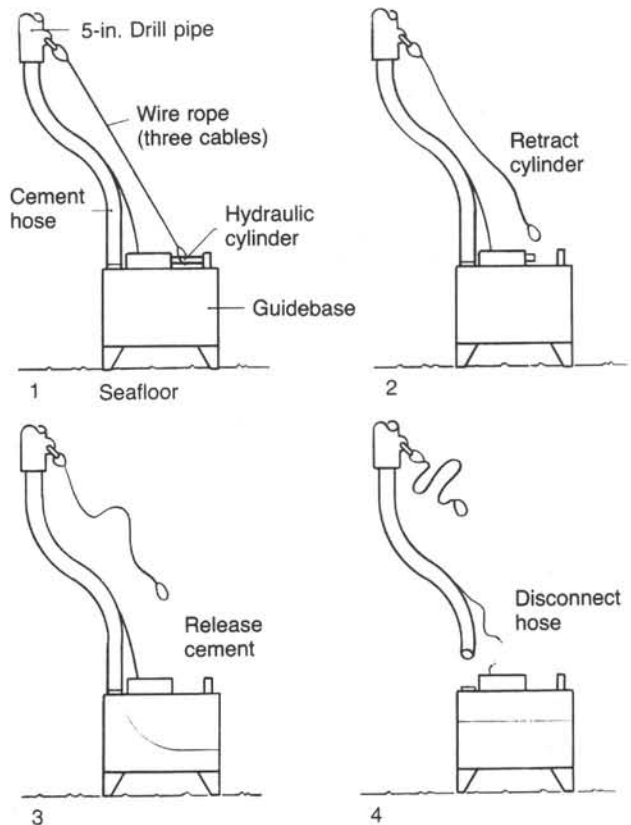
Figure 7. Diagrams showing HRGB landing and cementing sequence (from Shipboard Scientific Parties, 1988).

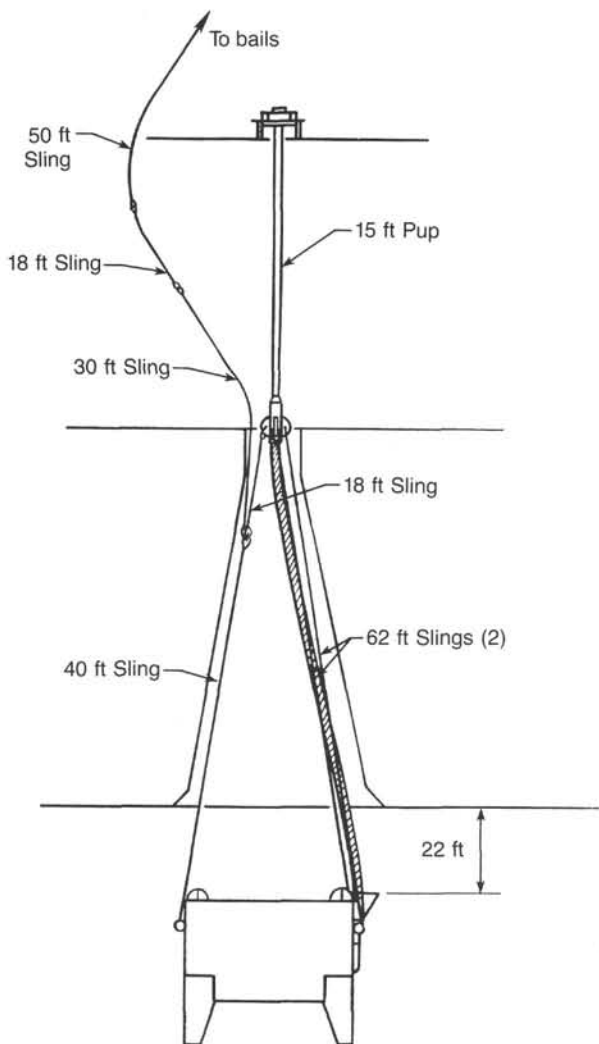
Figure 8. Diagram of the HRGB running configuration with 15-ft pup joint.

By using a 15-ft pup joint instead of both 15- and 5-ft pup joints used previously on top of the HRGB running sub, we were able to eliminate the dangerous operation of making up the pup joint connections in the moon pool with rig tongs and tuggers (Fig. 8). The new procedure requires that the 15-ft pup joint on top of the HRGB running sub be made up to the HRGB pad-eye running sub while still on the rig floor. Using only the 15-ft pup joint on top of the HRGB running sub provided adequate clearance below the rig floor for installing the rotary plug with the HRGB running subassembly hung off the moon-pool doors. This modification of the running procedure saved an hour of rig time.

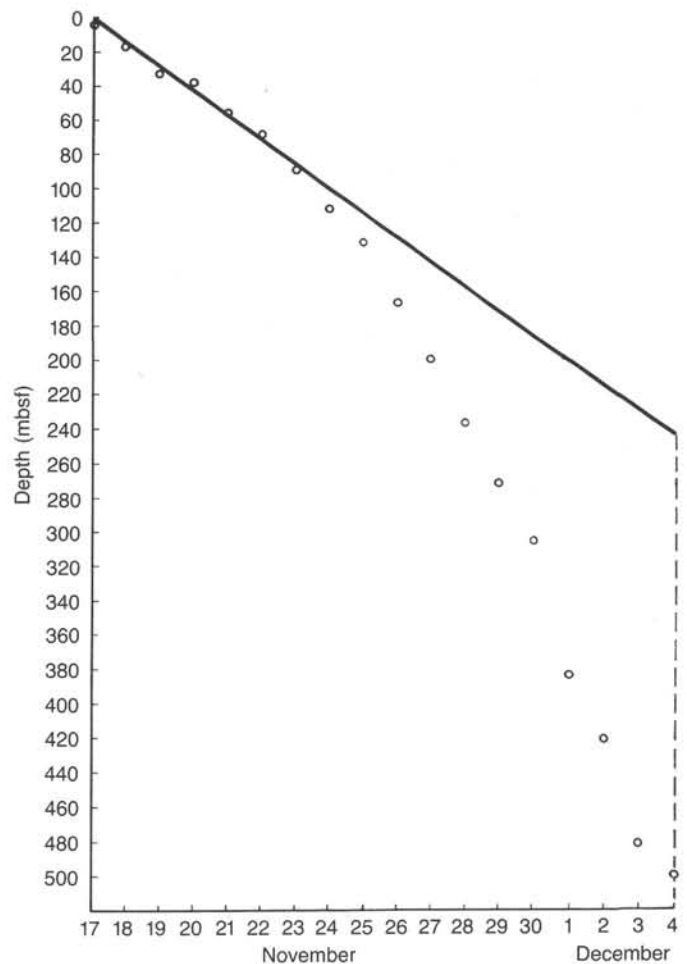
Figure 9. Plot of coring time vs. depth for Hole 735B. Solid line = projected depth at the end of 18 days of drilling; dots = realized depths.

Hole 735B was drilled to a depth of 500 m in 18 days. This included the time required for pipe trips, reentries, and BHA inspection. Figure 9 shows time vs. depth for Hole 735B during the 18-day drilling period. A total of 434 m of core was recovered for an average recovery rate of 86.9% (calculated for all Hole 735B bit runs).

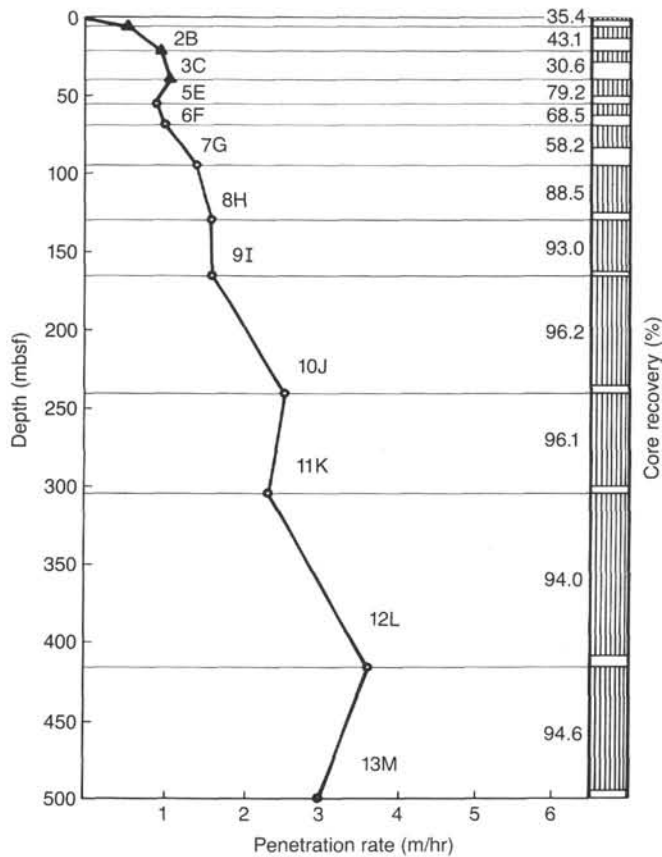
Figure 10. Plot of 9.875-in. core bits run in Hole 735B using type C7 and C57 cutting structure at 60 rpm, 23,000 lb WOB, and 325 gal/min vs. penetration rate. Triangles represent 10.5 x 2.25 in. PDCM coring bit runs; circles indicate 9.875 x 2.25 in. RCB bit runs. 2B, 2C, etc. = bit numbers (see Table 2).

As the hole advanced, penetration rate increased (see Fig. 10), primarily as a function of decreasing degree of mylonitization of the gabbro being drilled. However, a secondary factor contributing to increased penetration rate was an increase in weight on bit from 15,000 to 23,000 lb. In deeper sections of the hole, where penetration rates were 3.7 m/hr (Fig. 10), the high core recovery and good penetration rates were attributed to (1) the massive nature of the gabbro being cored, (2) excellent hole stability (lack of hole break outs and rubble infill), and (3) the effective removal of drill cuttings.

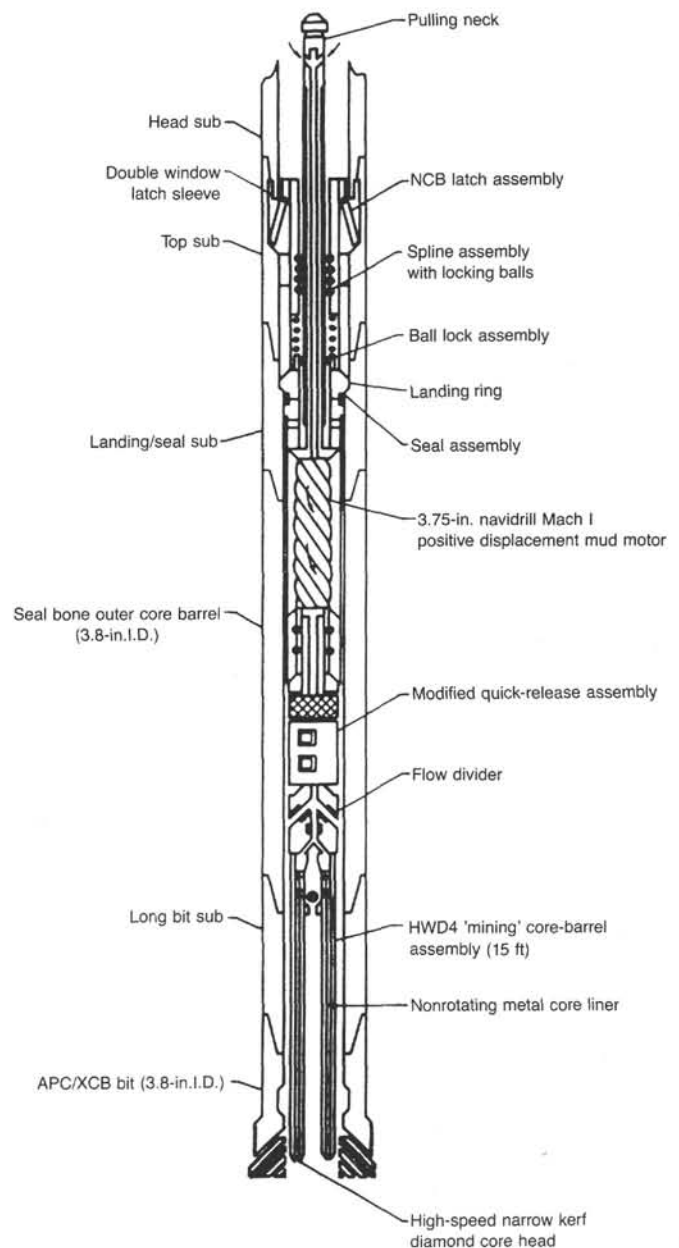
Figure 11. Diagram of the 3.75-in. navidrill core barrel.

The upper, middle, and lower sections of the navidrill coring system (NCB) were assembled and readied for use during Leg 118 (Fig. 11). The navidrill is run in on the wireline or allowed to fall freely down the drill pipe and landed in the BHA (Fig. 12). A flow rate is established (approximately 30 gal/min) down the drill pipe that unlatches the NCB assembly, allowing it to enter the open hole. This flow rate is increased to 80 to 120 gal/min, which rotates the drill motor. This in turn rotates the core-barrel assembly (Fig. 13). Attached to the core barrel is a diamond coring assembly (3.75-in. outside diameter x 2.25-in. inside diameter). As the core barrel advances in the open hole (up to 3.65 m [12 ft]), the core enters the core barrel. After cutting the core, the NCB coring assembly is retrieved by wireline, com-

To free the NCB coring assembly (Fig. 11), we had to cut the core barrel in three places. The core barrel was bent about 1 m from the NCB bit, and was slightly bent for two-thirds of the entire barrel length. We encountered extreme difficulty when extending the spline out to remove the core barrel. When the core barrel extended out onto the seafloor, significant galling occurred. After removing the lower and upper sections from the outer core barrel, we tried to relatch the thruster adapter-ball latch assembly. After we worked the female spline onto the thruster adapter, the assembly jammed. The ball ports in the female spline were 0.5 in. from the ball groove in the thruster adapter when the latch system jammed. We had to cut the landing and dampening sleeves off the female spline to release compression on the balls and thruster adapter shaft. No grit or sand was found inside the system. The springs remained loaded until we cut into the sleeve. Inspection of the male spline revealed significant galling along the corners of the spline where the balls make contact. The female spline would no longer slide along the male spline unless we applied excessive force with tuggers.

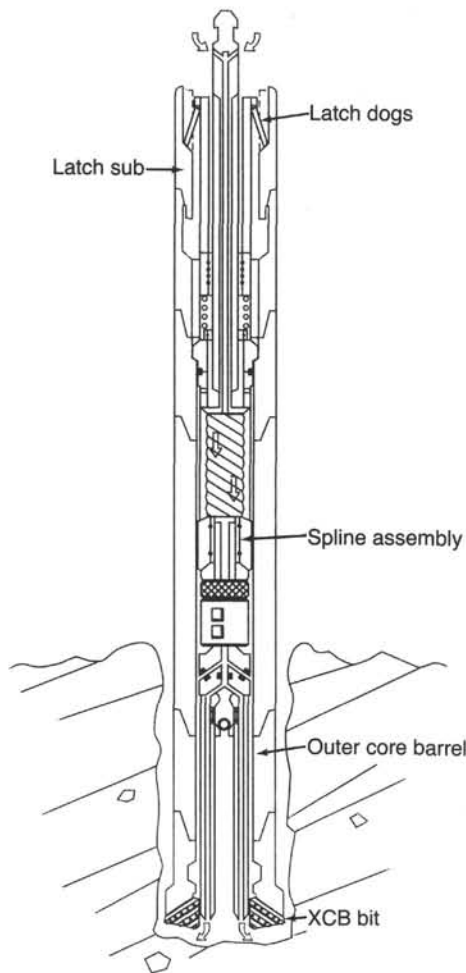
Figure 12. Diagram showing operational sequence when deploying the navidrill core barrel. Sequence of events is as follows: (1) Land NCB in outer core-barrel assembly; (2) Place XCB bit on bottom and circulate to determine beginning flow and pressure parameters; (3) Lock spline assembly in up position and engage NCB latch deep in latch sub.

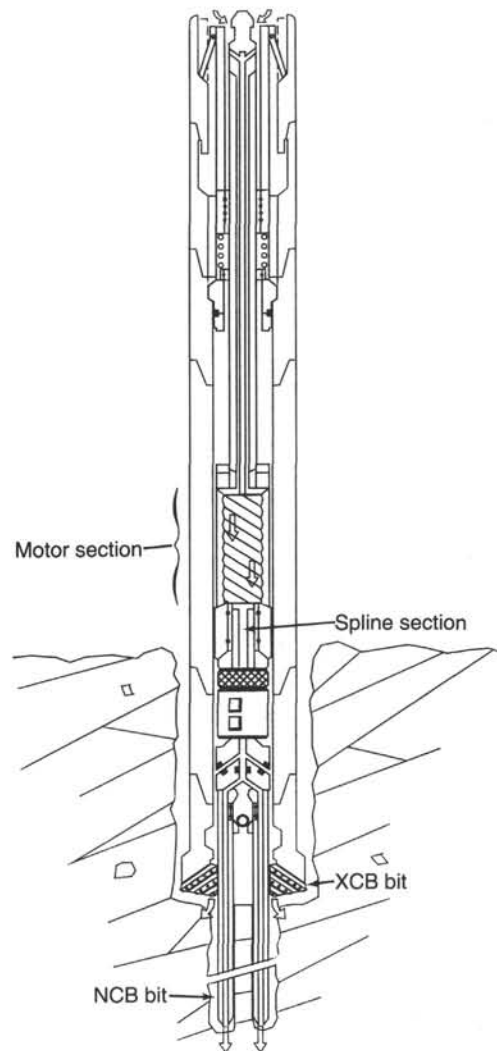
Figure 13. Diagram of the navidrill core-barrel operational sequence when coring ahead. Sequence of events: (1) Using circulation pressure, disengage locking balls on spline assembly; (2) Increase flow rate to produce desired WOB; (3) Monitor flow and pressure parameters while coring. A constant high pressure probably indicates motor stall. A constant low pressure probably indicates core block; (4) NCB system penetrates ahead of XCB bit as coring begins.
