## 5. OPERATIONS REPORT<sup>1</sup>

Michael A. Storms<sup>2</sup>

### OVERVIEW AND ACCOMPLISHMENTS

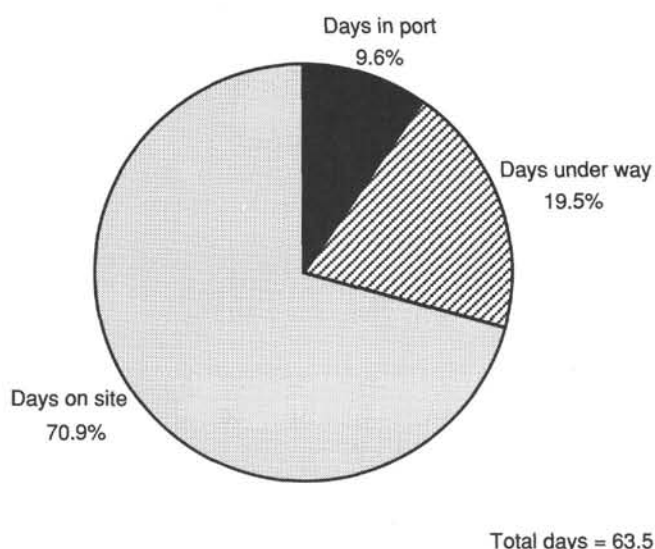
Figure 1. Leg 132 total time distribution.

unsedimented spreading ridge. Two other secondary drilling objectives, the chert-chalk sequences at Shatsky Rise and the shallow-water reefal carbonates at M.I.T. Guyot unfortunately had to be abandoned when leg operating time expired (Fig. 1, Table 1).
