## 5. DIAMOND CORING SYSTEM PHASE IIB<sup>1</sup>

### INTRODUCTION AND BACKGROUND

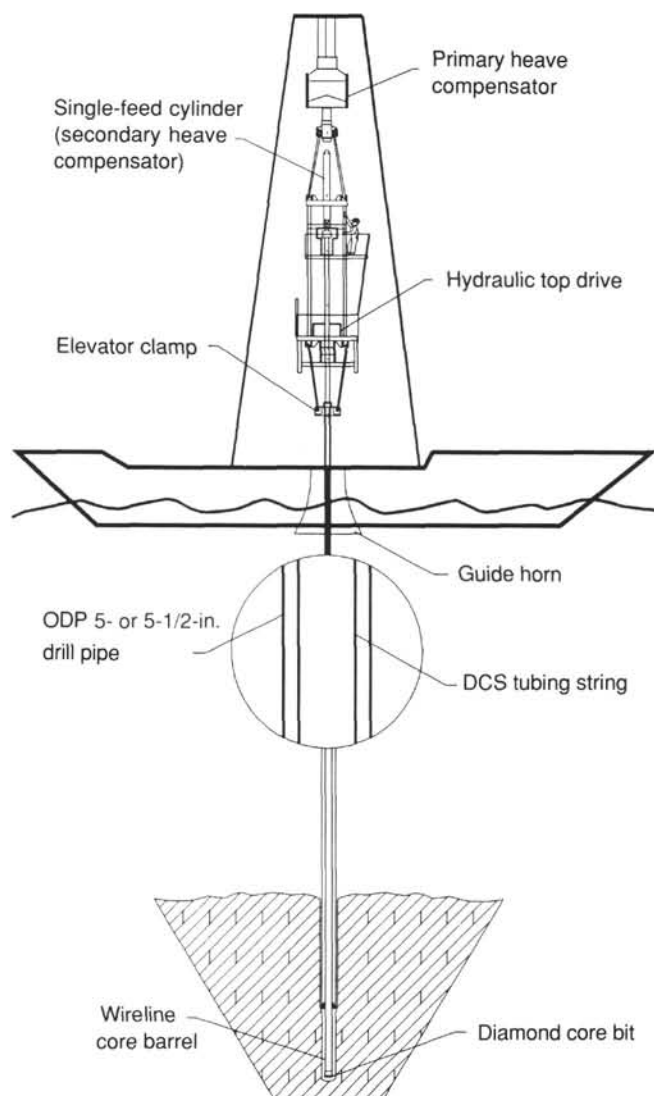
Figure 1. Diamond coring system, Phase I (2000 m depth capacity).

the relatively large coring bits and 5- or 5-1/2-in. drill pipe. The prototype DCS incorporated a hydraulic top drive and a hydraulic feed and compensation system controlled by a computer. The system was suspended from the 400-ton primary heave compensator in the derrick. Residual heave was then measured with an accelerometer mounted directly on the DCS platform. This signal in turn was fed into the secondary heave compensator computer to create the drive for a servo valve. The servo valve then created the necessary drive for a hydraulic cylinder from which the DCS top drive, tubing, and bit were suspended (see Fig. 1).

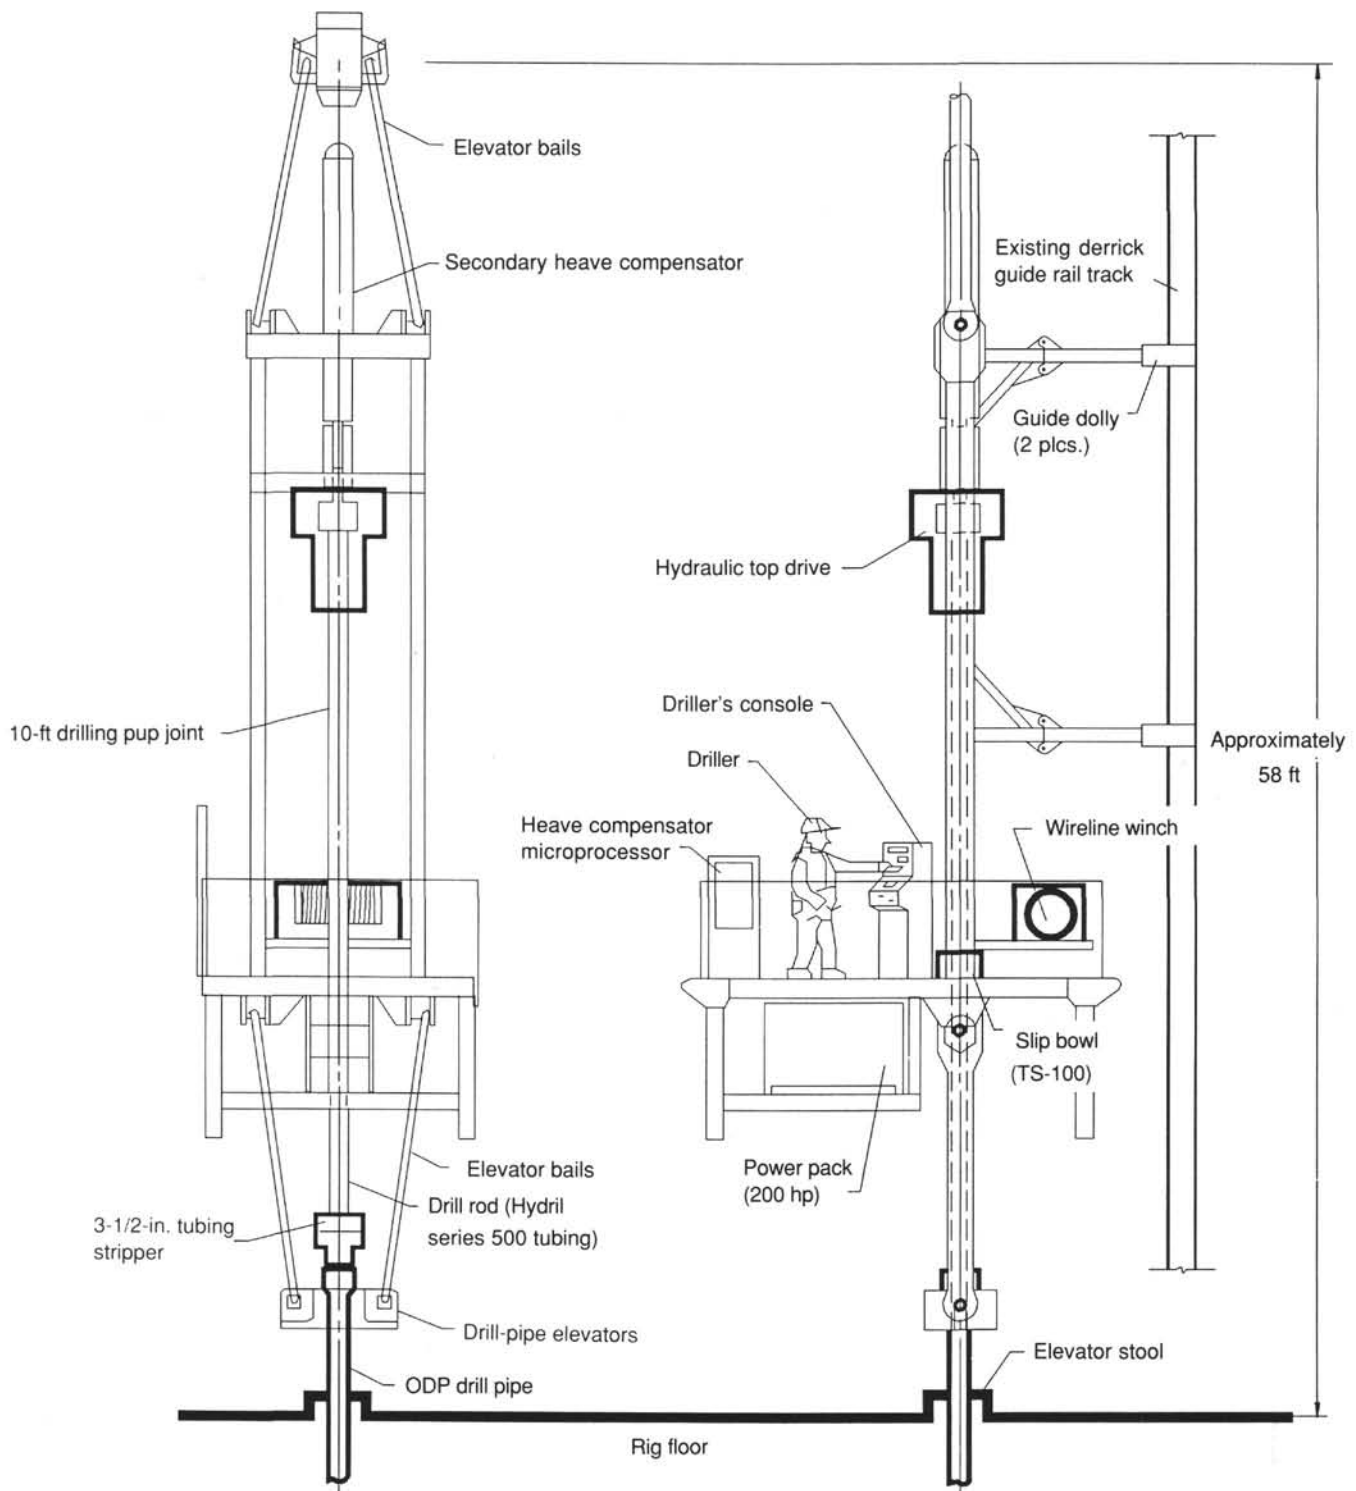
Figure 2. DCS platform configuration.

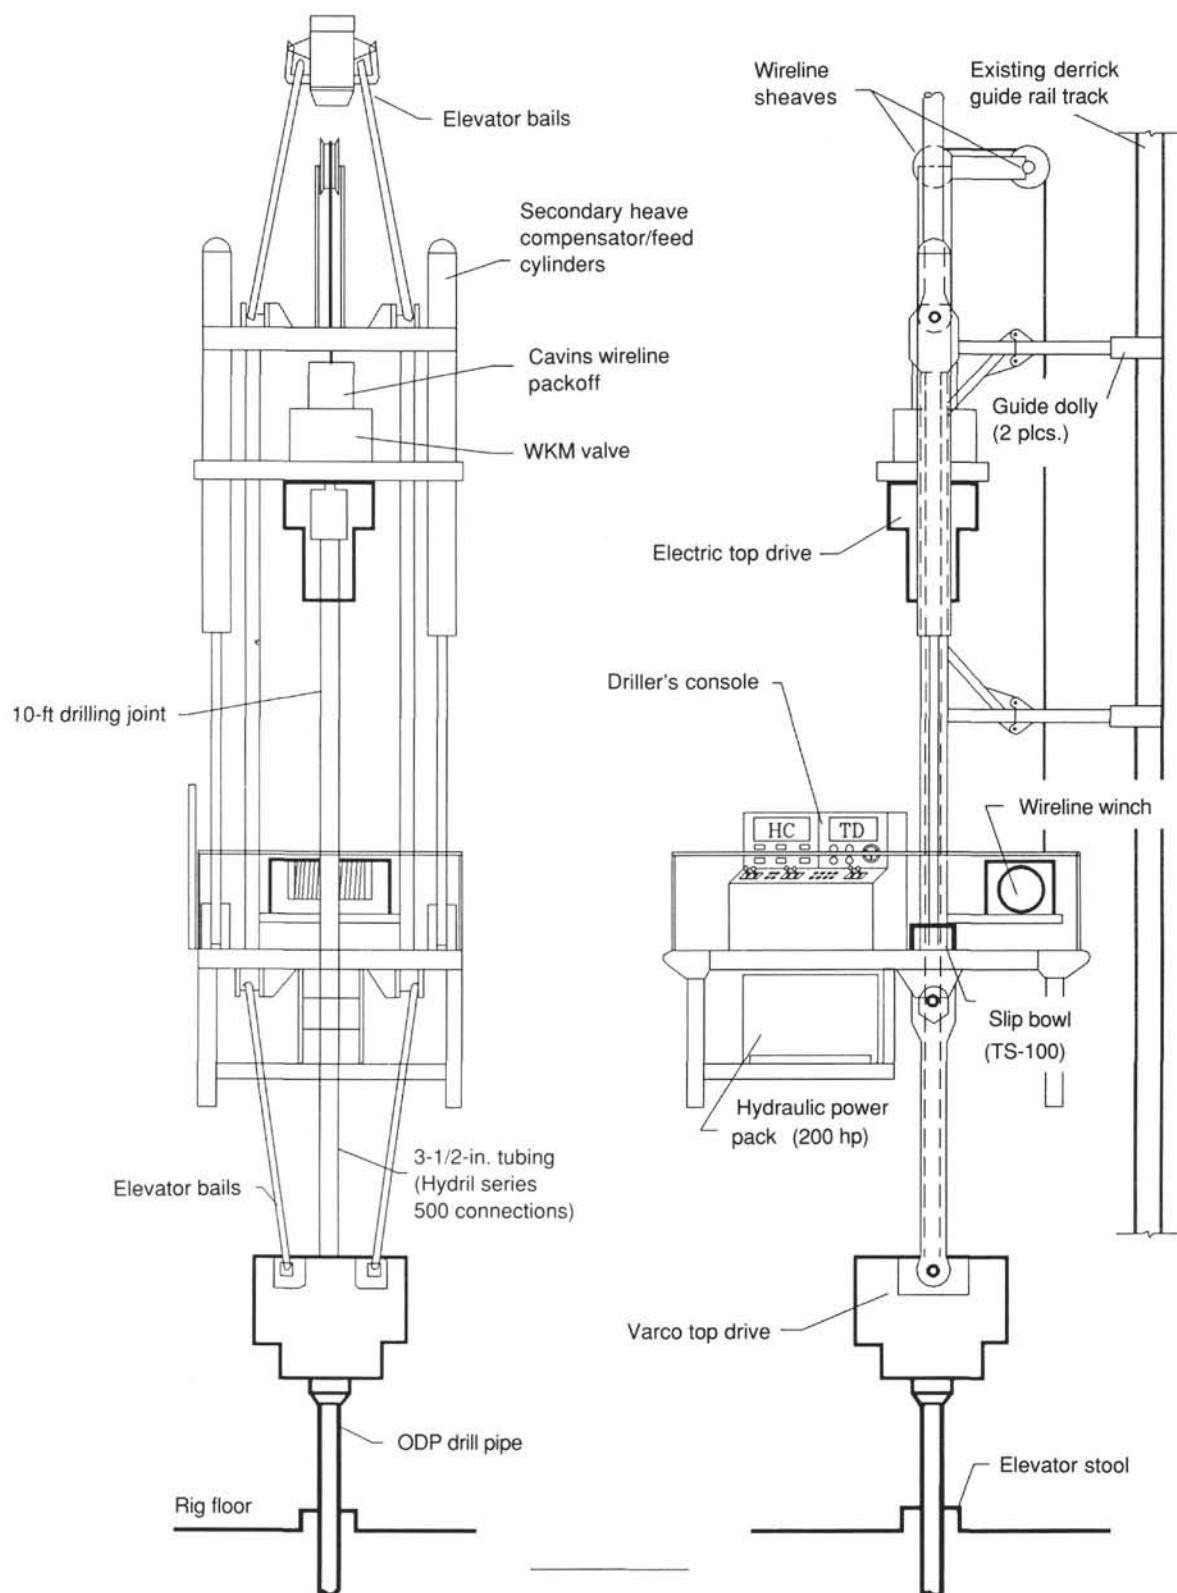
Figure 3. DCS platform configuration, Phase II (4500 m depth capacity).

Phase II development expanded on the capabilities of the Phase I equipment. The first significant design change was to increase the system's depth capability. The new specification called for a depth capability of up to 4500 m, with residual heaves of up to  $\pm 12$  in. To accomplish this, the feed and compensation systems were modified. The Phase I compensator was entirely an active system and employed only one cylinder, located above the top drive in the center of the mast structure (see Fig. 2). The Phase II hydraulics were designed such that compensation was a combination of active and passive methods, and employed two cylinders for handling the load of the top drive and tubing (see Fig. 3 for a schematic of the Phase II DCS).
