OCEAN DRILLING PROGRAM

LEG 101 PRELIMINARY REPORT

BAHAMAS

Preliminary Report No. 1

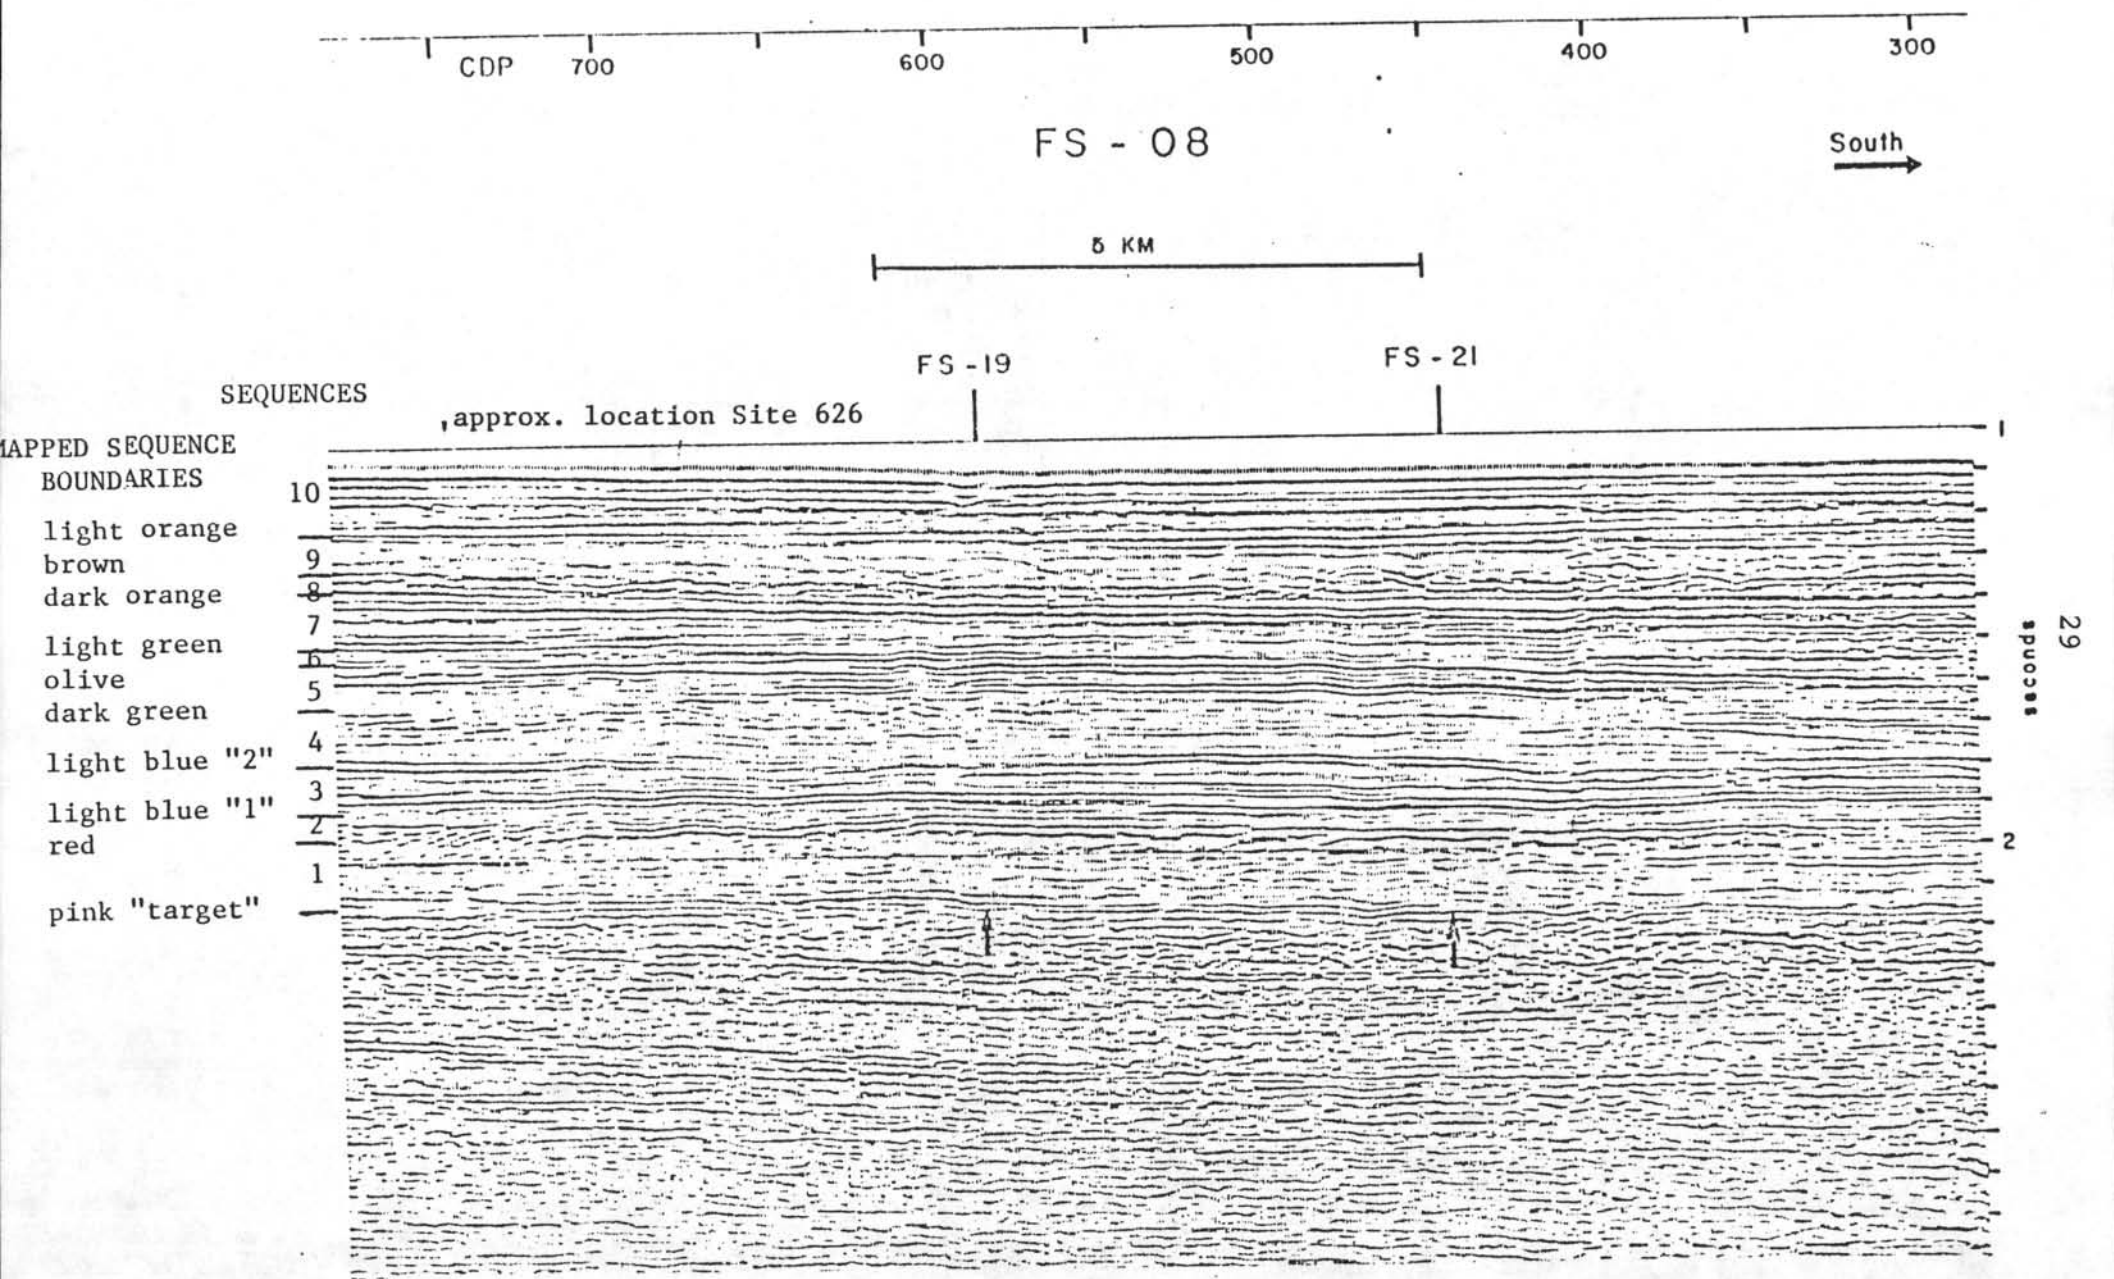
Figure 3. Sequences and sequence boundaries identified and mapped in the vicinity of Site 626.

Target horizon indicated by arrows

high-amplitude reflection with a pronounced compressional wave velocity increase to more than 4 km/sec (Figure 3). During Leg 101, six sites were drilled in an attempt to sample this horizon: 626, 627, 632, 634, 635, and 636 (Figures 2 and 4).

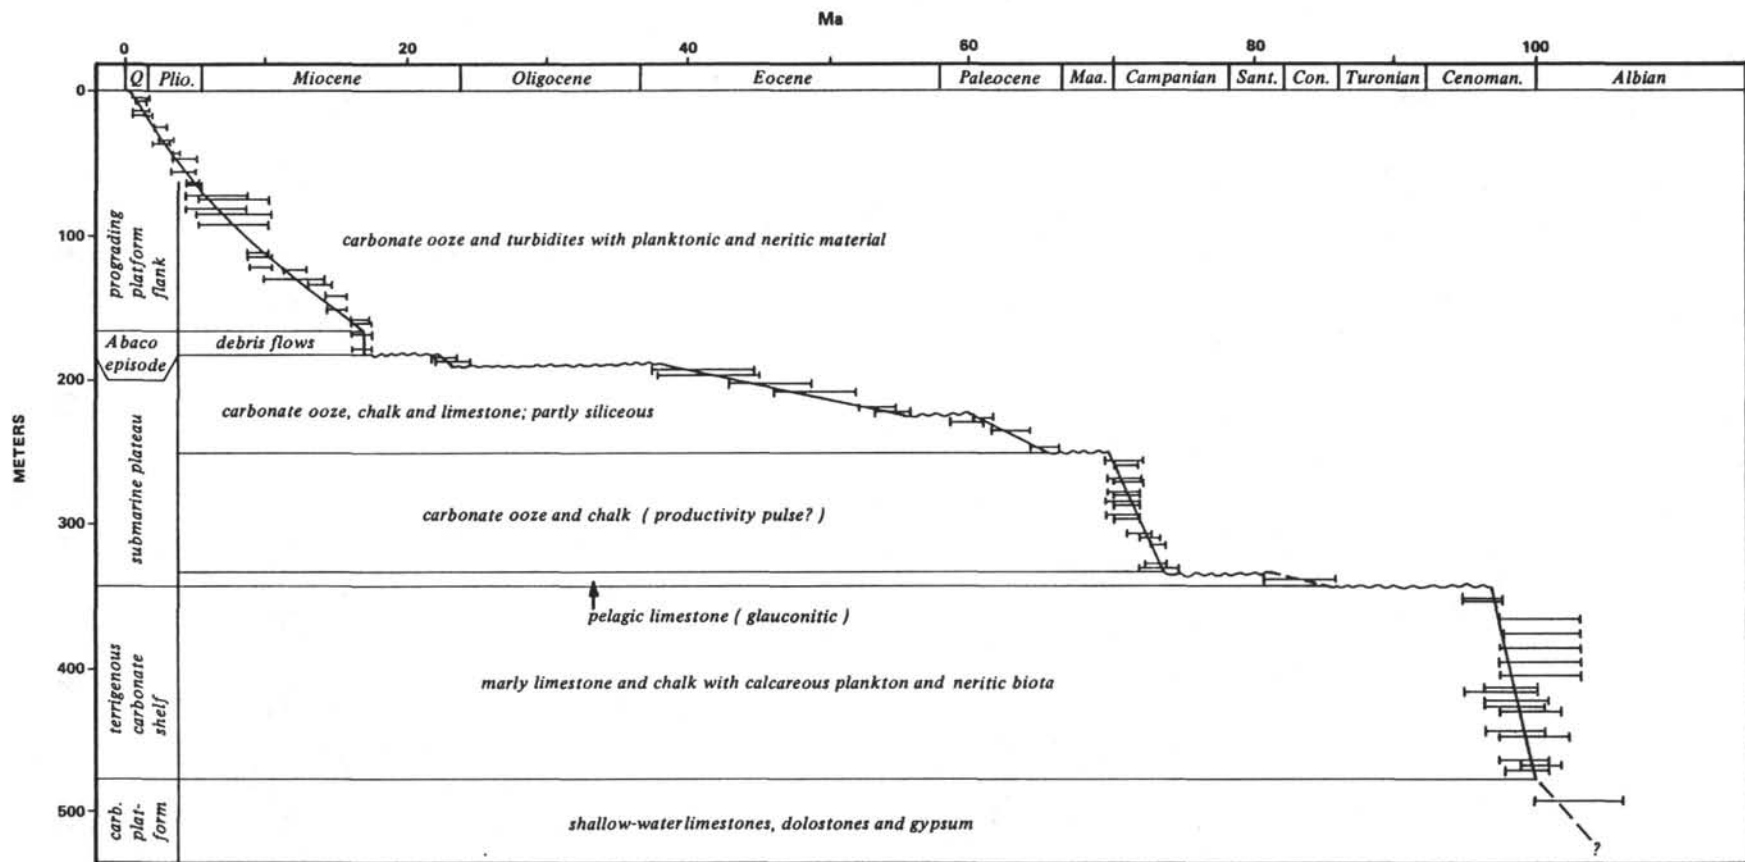
Figure 6. Age-depth curve and geologic history of Site 627 on southern Blake Plateau. Drowning of carbonate platform during mid-Cretaceous crisis is followed by partly terrigenous deposition on a shelf, and by 80 Ma of slow pelagic deposition on a submarine plateau. In the last 20 Ma, the area has come under the influence of the prograding Bahama platform again. "Abaco episode" refers to a widespread incidence of debris flow deposition in the middle Miocene first documented in the Blake-Bahama basin during DSDP Leg 44 (Benson, Sheridan et al, 1978).

Leg 101 recovered shallow-water carbonates and evaporites of the megabank under the southern Blake Plateau. In the Straits of Florida, the carbonate platform was not reached but a close stratigraphic tie was established with an exploration well on Great Bahama Bank, 60 km to the northeast. The continuity of seismic records in the region between Site 626 and the Great-Isaac I well strongly suggests that the entire Straits of Florida is underlain by a continuous carbonate platform. The two holes indicate, furthermore, that the margin of Great Bahama Bank has not remained stationary since the mid-Cretaceous, but rather has alternately retreated and prograded tens of kilometers during the past 100 Ma. Blake Plateau and Little Bahama Bank display a similar rhythm of mid-Cretaceous drowning and retreat followed by Late Tertiary expansion of the platforms (Fig. 6).
