OCEAN DRILLING PROGRAM

LEG 110 PRELIMINARY REPORT

STRUCTURAL AND HYDROLOGIC FRAMEWORK OF THE NORTHERN BARBADOS RIDGE COMPLEX

Preliminary Report No. 10

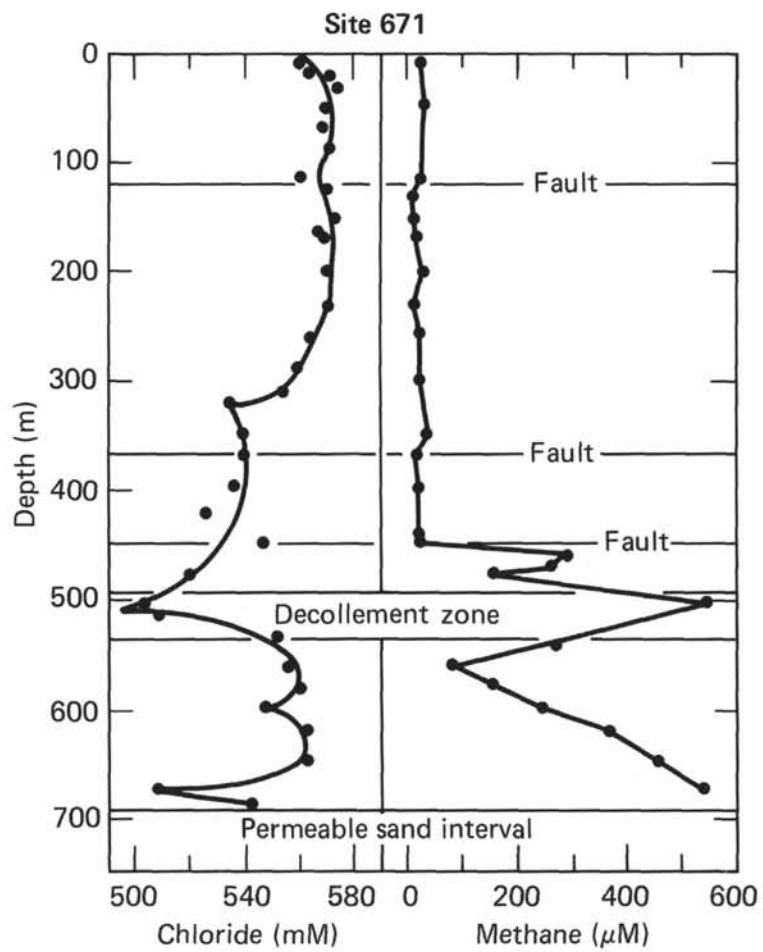
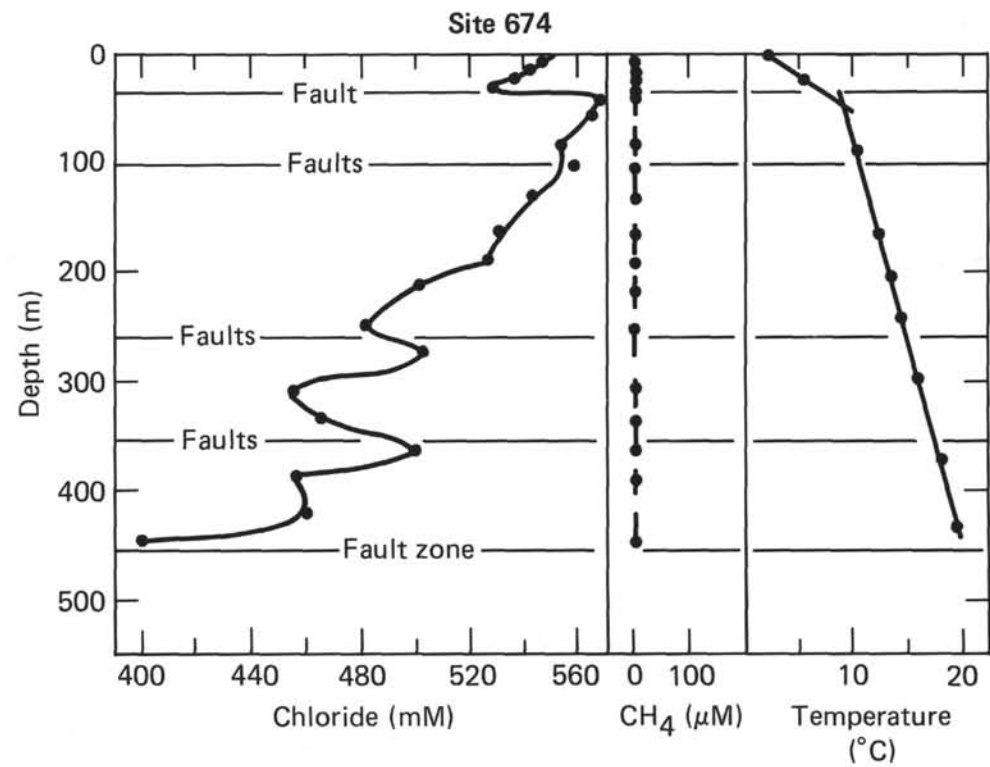
Figure 4

Figure 4. Relationship of structural features, pore water chemistry, and temperature gradients at two Leg 110 sites. Low chloride and high methane pore water concentrations at Site 671 correlate with the decollement zone and characterize the methane-bearing fluid regime. At Site 674 many, but not all, faults correlate with lows in the chloride curve, suggesting some faults may be active conduits of fluid transport. The overall low chloride values probably reflect a diffusive lowering of this constituent due to long-term flow of fluids through the highly faulted section. The correlation of low chloride concentrations in pore water, with the change in temperature gradient at 30 to 40 m sub-bottom at Site 674, suggests currently active flow through this zone.

adjacent faults, and the sandy interval below the decollement. However, no methane anomalies are recognized in faults in the accretionary wedge above the decollement, even though these surfaces display low chloride values indicating flow (Fig. 4). The accretionary wedge and underthrust sediment appear to constitute discrete fluid reservoirs separated by the top of the decollement zone.
