**OCEAN DRILLING PROGRAM  
LEG 156 PRELIMINARY REPORT  
NORTH BARBADOS RIDGE**

August 1994

Preliminary Report No. 56

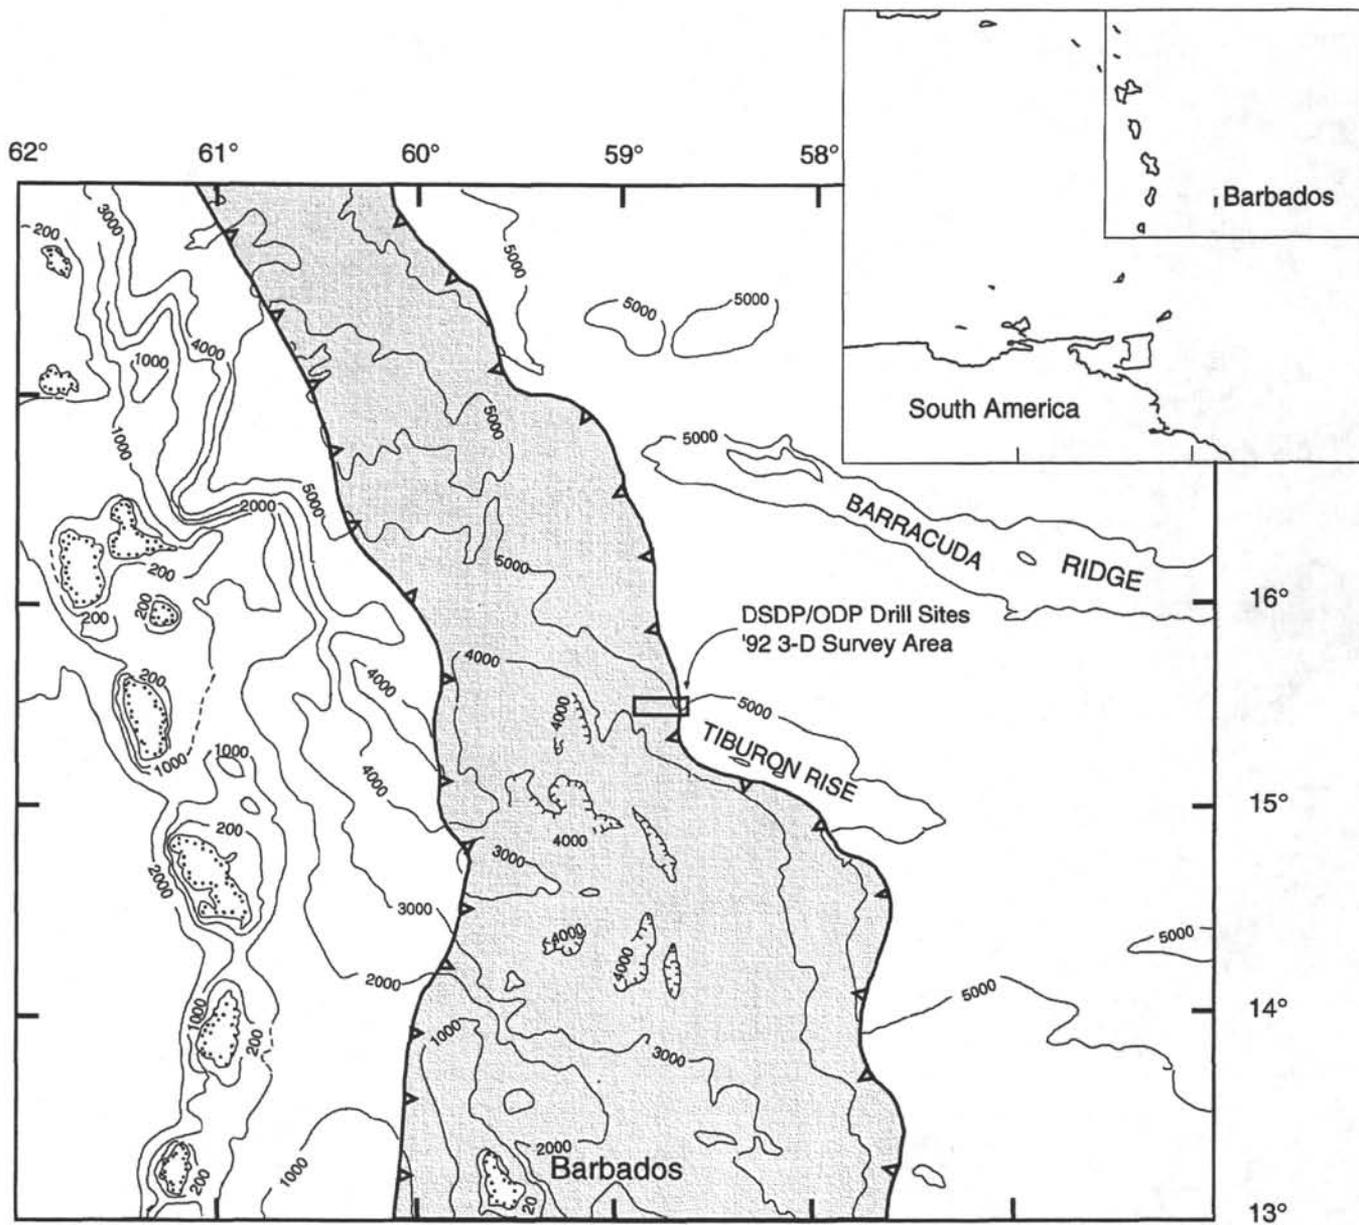
Figure 1

Figure 1. Index chart of the Lesser Antilles. Stippled zone is the extent of the northern Barbados Ridge accretionary prism. The Tiburon Rise dams along-axis trench transport, partly explaining the reduction in width of the prism to the north. A box illustrates the location of the DSDP/ODP transects. The box is approximately the size of the 3-D seismic survey that identified the drilling locations on Leg 156 (figure modified from N. Bangs, personal communication). Bathymetry shown in meters.

Site 947 (proposed Site NBR-3) was positioned, in part, to explore the high-amplitude negative-polarity fault reflection for comparison to the seismic character at Site 948, where the décollement exhibits positive polarity (Figs. 1, 2, and 3). For the first time in the history of ODP, we deployed a logging-while-drilling (LWD) system. This logging system was necessary because hole instability had prevented wireline logging on both Leg 78A and Leg 110. The LWD program at Hole 947A obtained logs from the seafloor to 574 mbsf. Drilling conditions stopped the LWD about 60 m above the seismically identified décollement in a fault splay.

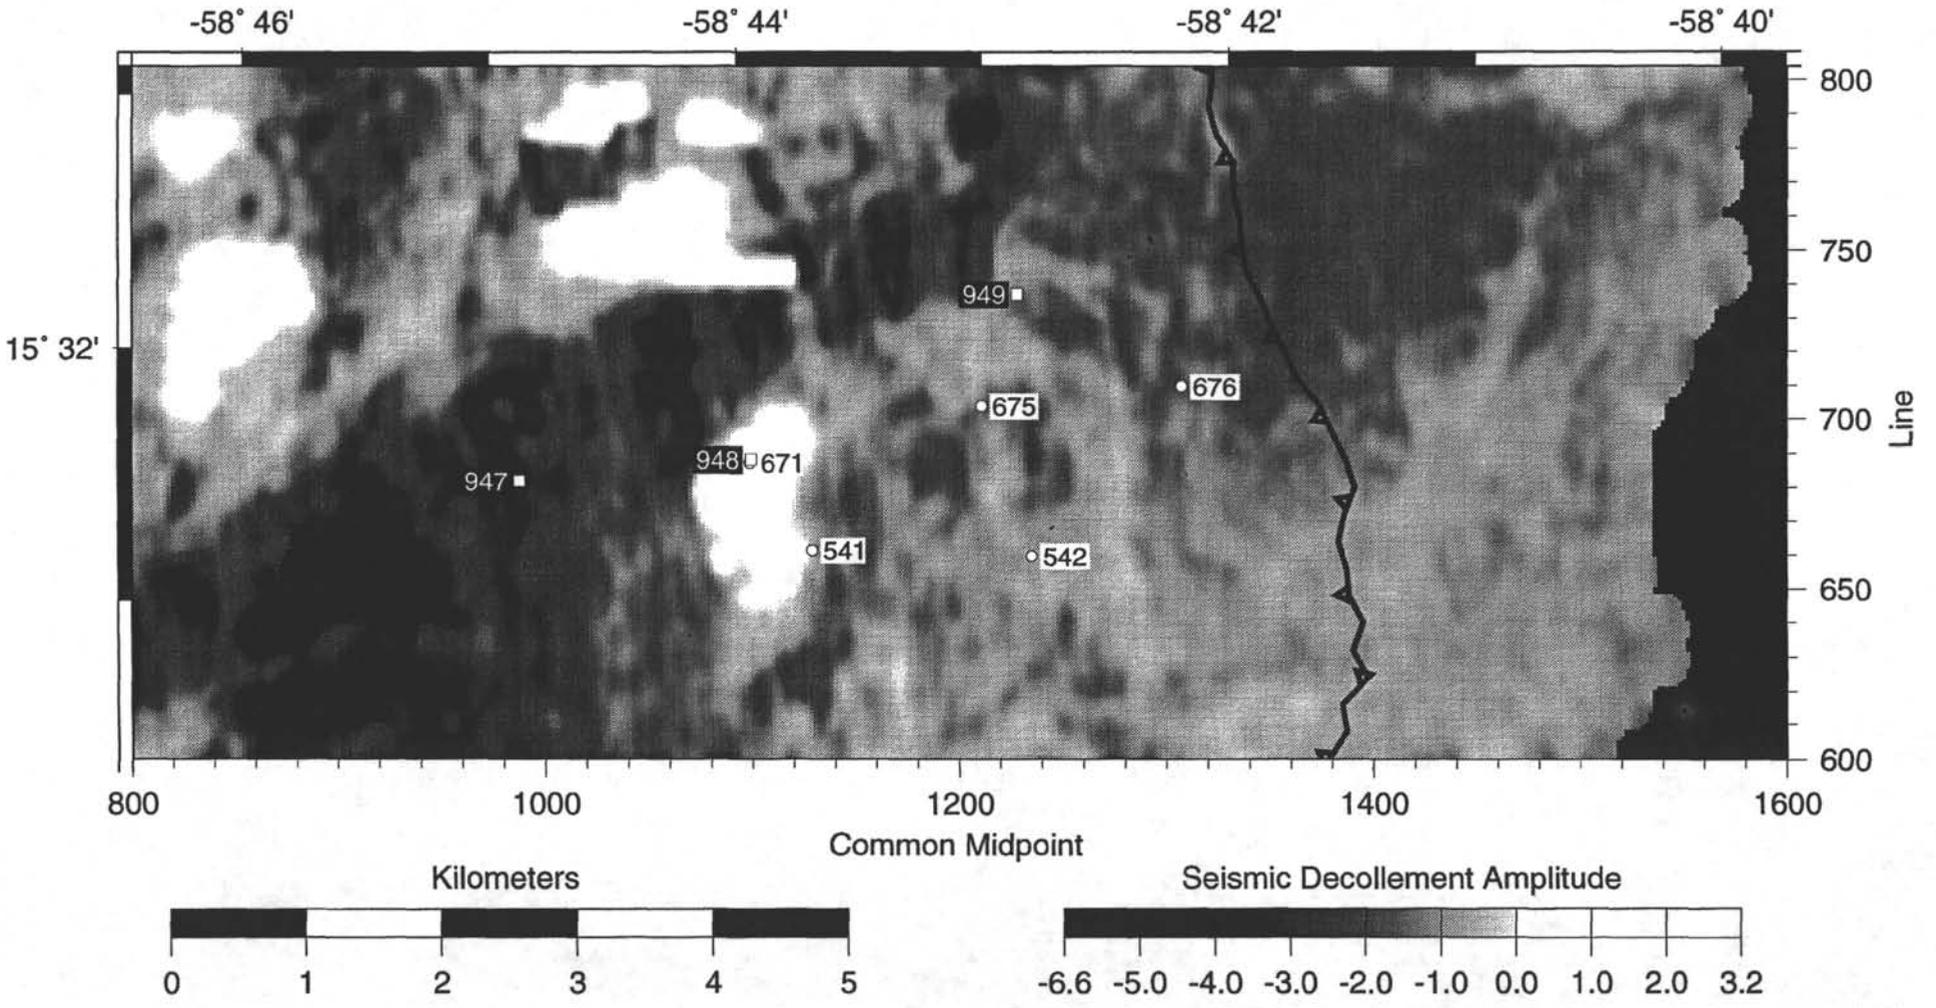
Figure 2

Figure 2. Map of décollement showing the Leg 156 drill sites superposed on a seismic amplitude map. The amplitude map is based on digitized 3-D seismic data. The frontal thrust, DSDP, and other ODP drill sites are shown.

Site 948 (proposed Site NBR-2) calibrates the positive-polarity seismic signature of the décollement (Fig. 3). It is also as close as we could navigate to Hole 671B, which penetrated the 40-m-thick décollement and 151 m into the underthrust section on ODP Leg 110 (Fig. 2). Hole 948A was dedicated to logging. Hole 948B was a jet-in test site. Hole 948C was dedicated to interval coring and logging. Hole 948D, 200 m south of Holes 948A and 948C, was cased to 535.3 mbsf for special experiments.

at Site 947 (Figs. 2 and 4). Seismic data define a shallow dipping series of splay faults at about 150 to 225 mbsf, cutting off near-horizontal reflections at about 275 mbsf and deeper, and the main décollement at 375 mbsf, marked by a reversed-polarity reflection. At 425 mbsf is another reversed-polarity reflection, thought to be either an incipient fault or a stratigraphic boundary.

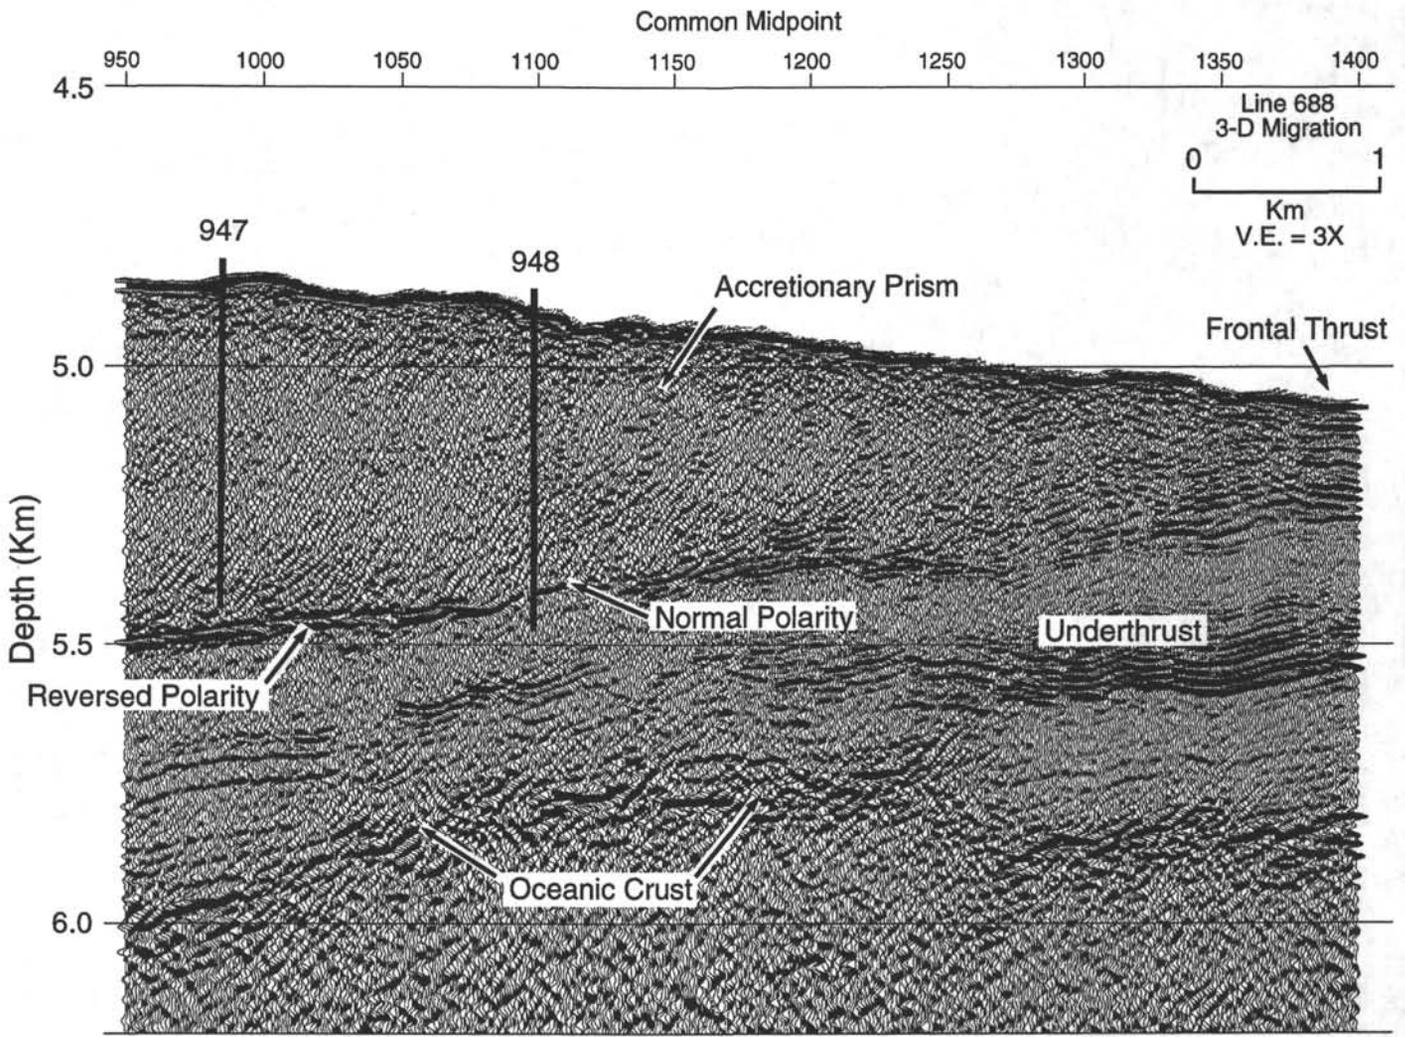
Figure 3

Figure 3. Seismic section illustrates reflection characteristics of the décollement at Sites 947 and 948. Section is in depth using velocity function derived from Site 671 (Shiple et al., 1994). Site 948 prism velocity = 1740 m/s; underthrust section velocity = 1779 m/s; Site 947 prism velocity = 1777 m/s; underthrust section velocity = 1811 m/s. Section gain was equalized with a 500-ms symmetric moving window.

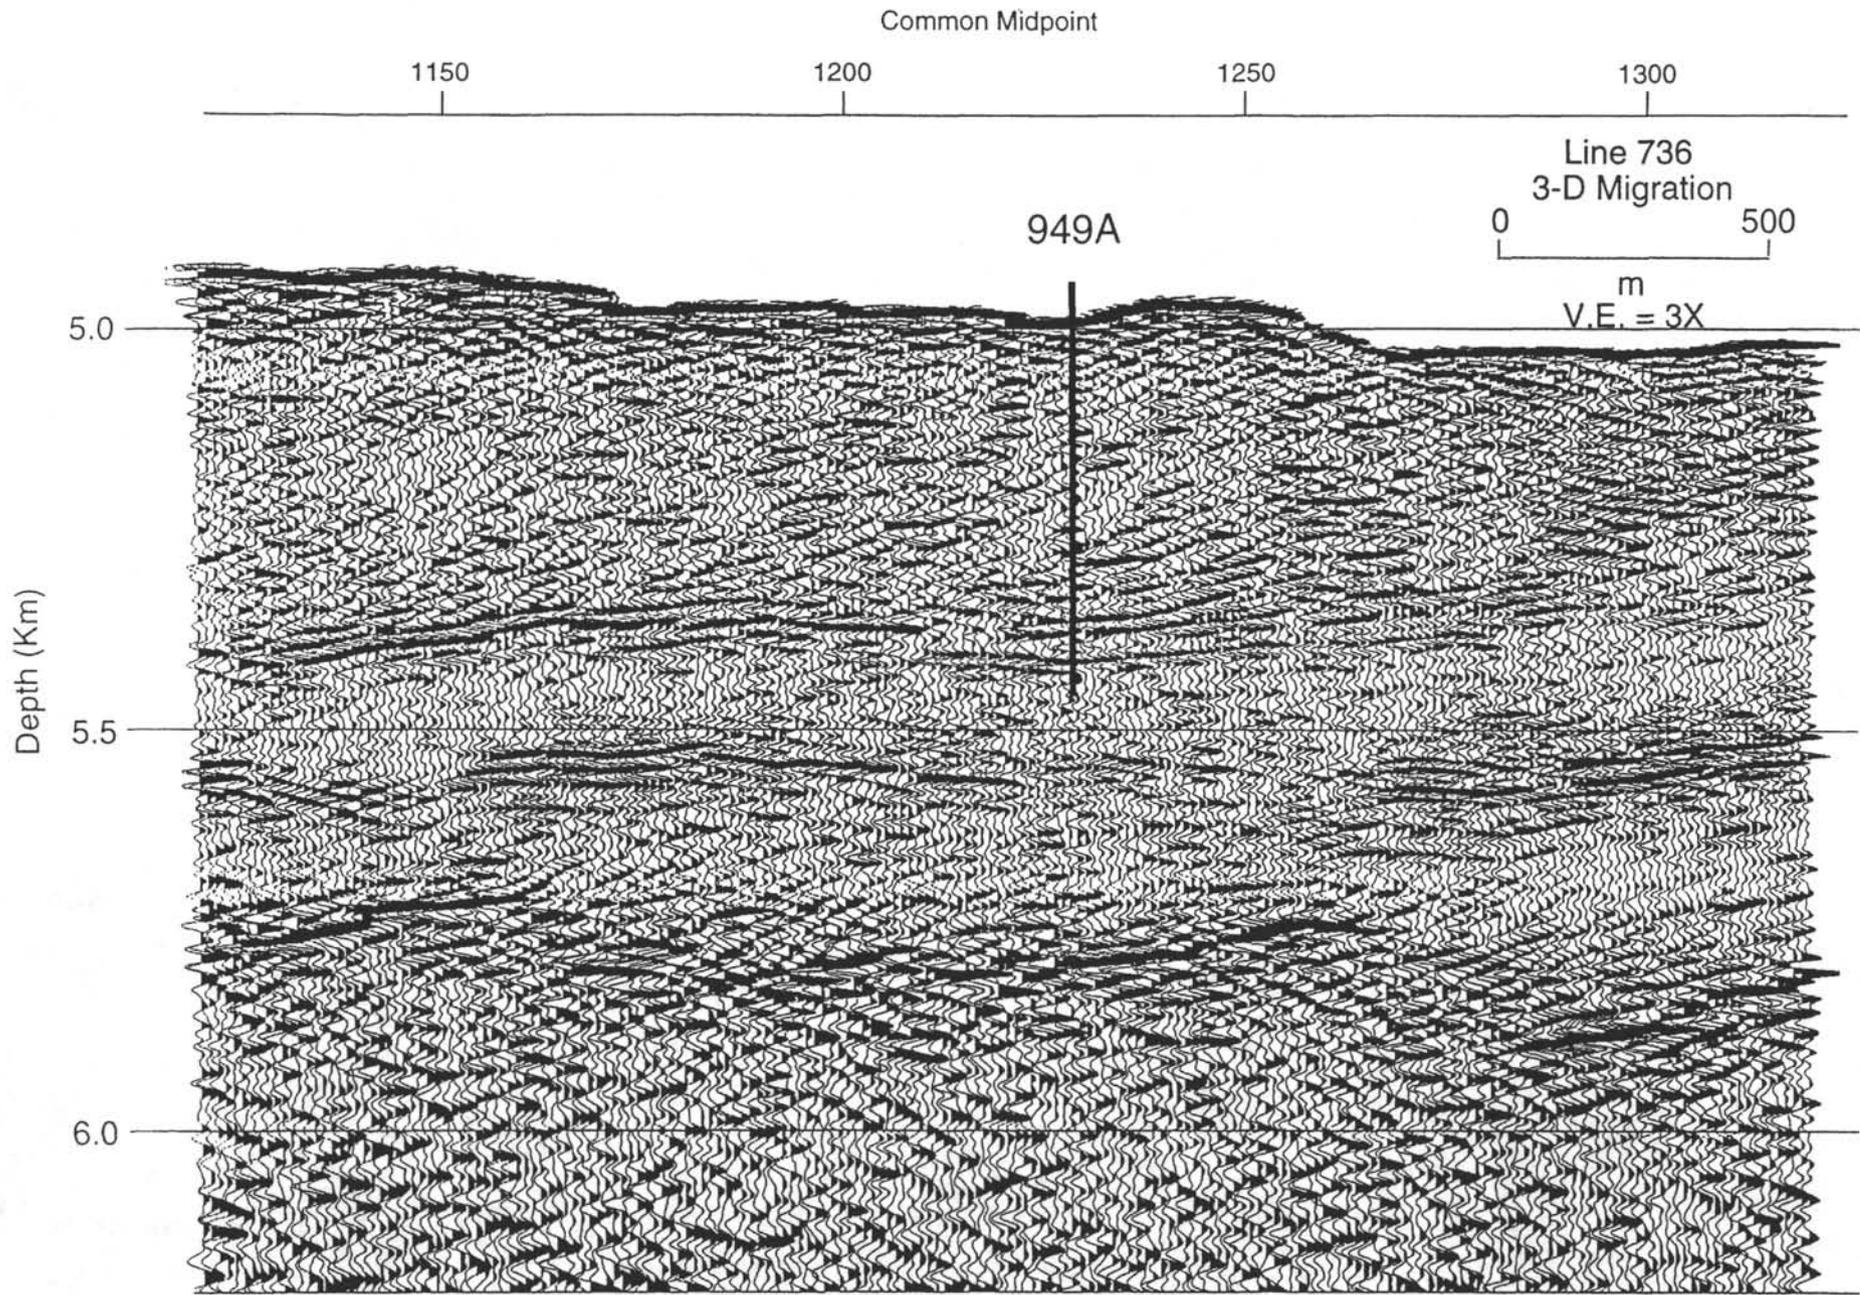
Figure 4

Figure 4. Seismic section illustrates reflection characteristics of the décollement at Site 949. Section is in depth using velocity function derived from Site 671 (Shiple et al., 1994). Specifically at Site 949 the prism velocity used was 1699 m/s, and the underthrust section velocity was 1743 m/s. Section gain was equalized with a 500-ms symmetric moving window.

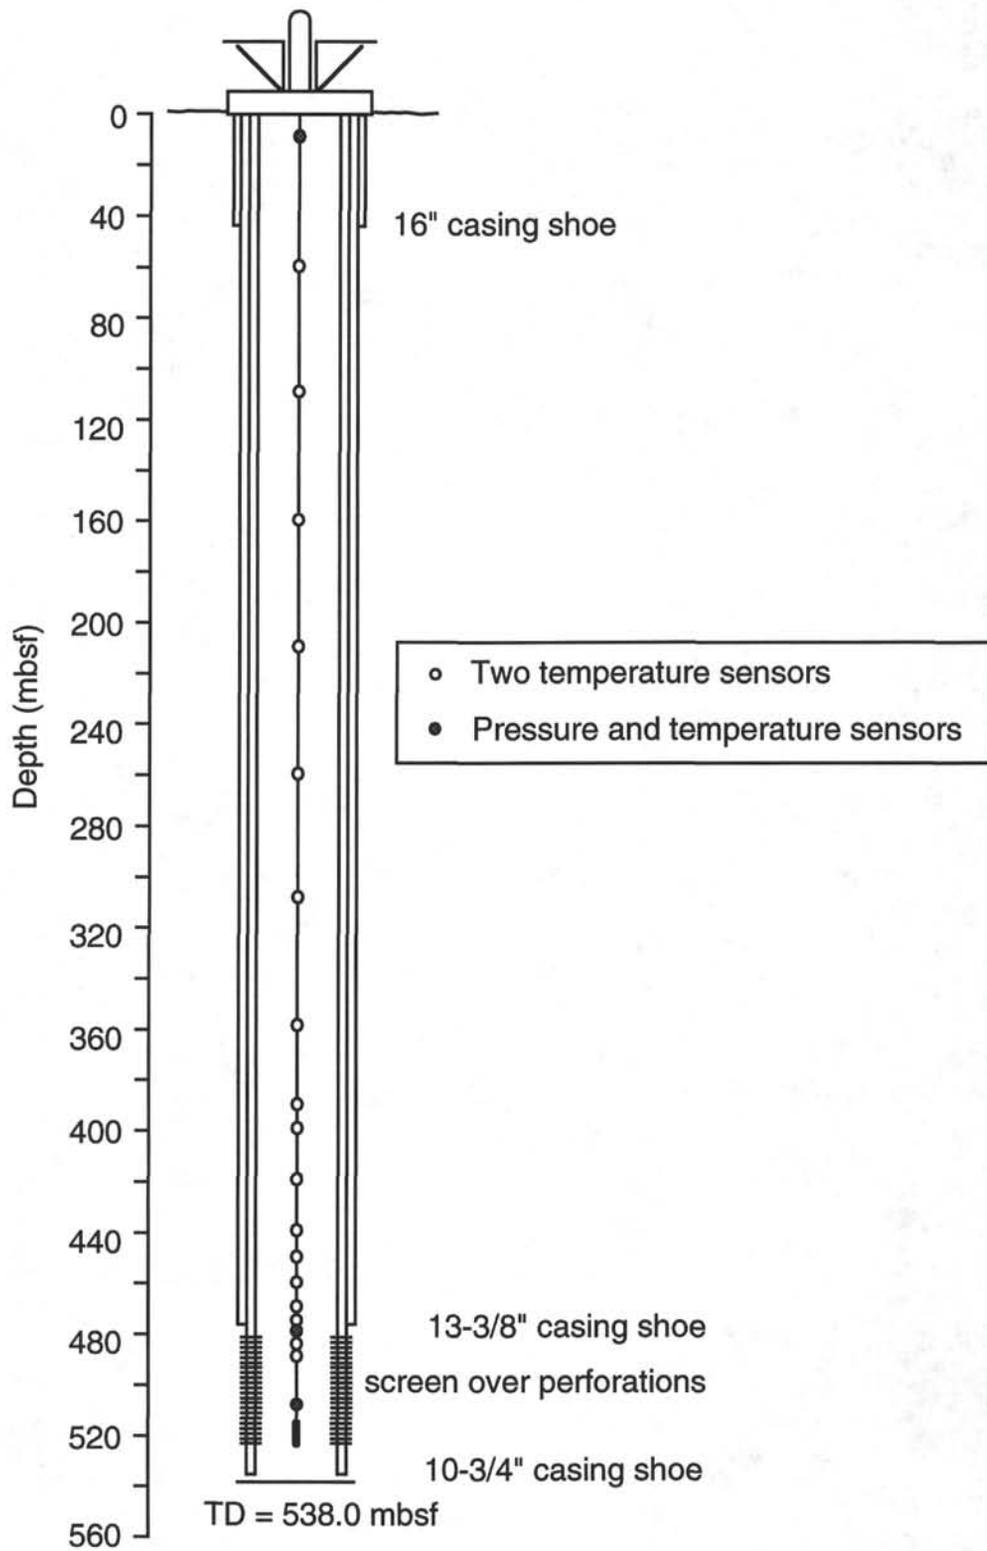
Figure 1. Final configuration of French-designed (IFREMER) sensor string, casing, and screen, deployed as part of a long-term borehole observatory (CORK) in Hole 948D.

Inability to achieve mechanical latching left only two operational choices. The CORK could be released with only the weight of the stinger and CORK to maintain the seal by gravity or the entire CORK and sensor-string assembly could be recovered to the drill floor, the sensor string removed, the running tool redressed, and the entire deployment procedure repeated. The principal drawback to the former choice was that the hydraulic seal of the CORK would be lost if/when the hole pressure at the CORK exceeded hydrostatic pressure by more than the pressure exerted by the CORK (about 1.0 MPa [145 psi], probably less than half the greatest formation overpressure at the middle of the screen). In addition to the impact of the latter option on operating time and remaining scientific objectives, there was a very high risk of damage to the French sensor array in pulling it clear of the reentry cone. We could not retrieve the IFREMER string without first bringing the CORK back to the ship, because the setting balls prevented engaging the data logger with the wireline. After the alternatives had been considered, the decision was made to release the CORK and to continue with the operational plan of the leg. The final configuration of the IFREMER sensor string in Hole 949D is listed in Table 3 and is shown relative to casing and screen positions in Figure 1.

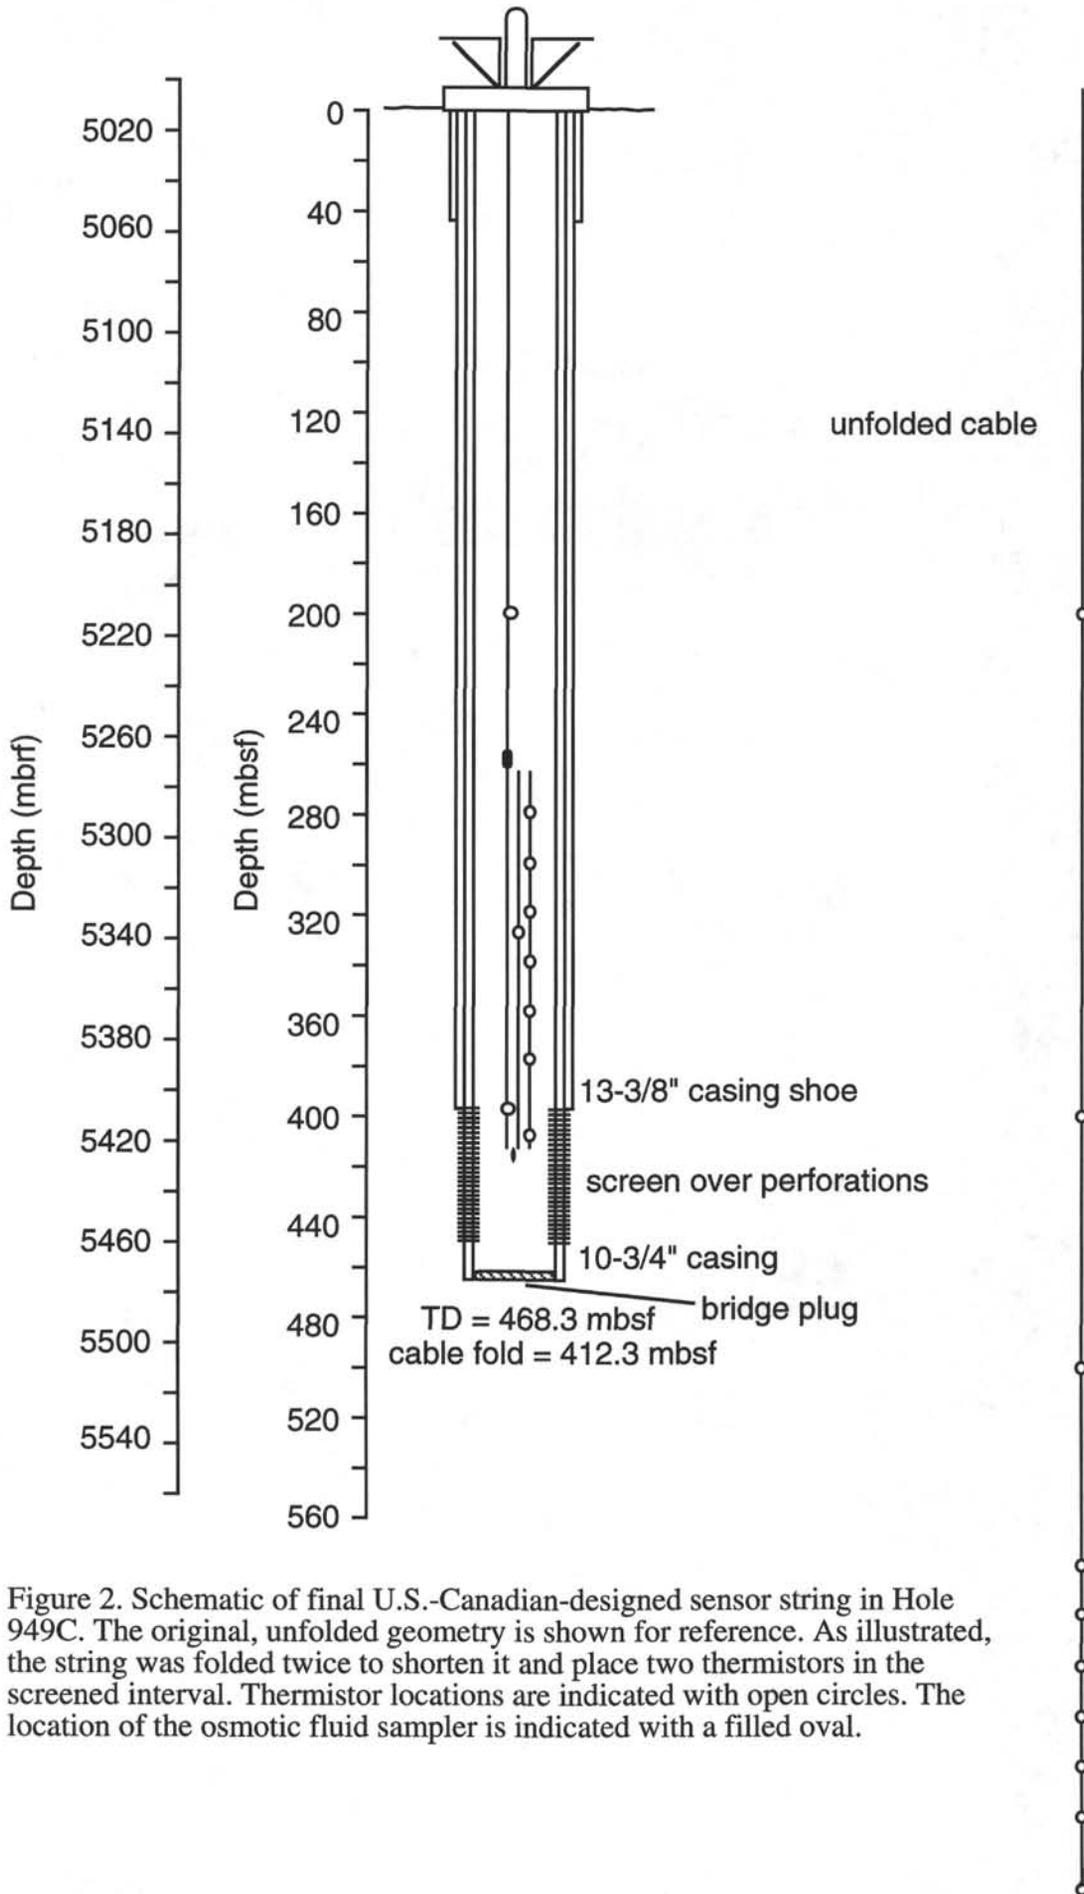
Figure 2. Schematic of final U.S.-Canadian-designed sensor string in Hole 949C. The original, unfolded geometry is shown for reference. As illustrated, the string was folded twice to shorten it and place two thermistors in the screened interval. Thermistor locations are indicated with open circles. The location of the osmotic fluid sampler is indicated with a filled oval.

In a frenzy of activity, a large group of technicians, scientists, and crew unpacked and modified a 715-m sensor array, folding and lashing the kevlar cable (Fig. 2 and Table 4). The new array and data logger were run to the CORK and landed. As before, there was no positive indication of latching--only the temporary "sticking." No time remained for protracted latching efforts, so the sinker bars were "worked" only a few times before the wireline was recovered. The anticipated task of laying down and repacking the thermistor string proved to be unnecessary, as the overshot cleared the top of the pipe without the data logger attached. Despite the uncertainty of latching, there was little choice but to proceed with setting the CORK and ending the leg.
